ADDRESS DUST AT POINT OF EMISSION

Dave Harasym, UK sales manager, **Martin Engineering**, looks at controlling fugitive dust emissions on limestone conveyor transfer point

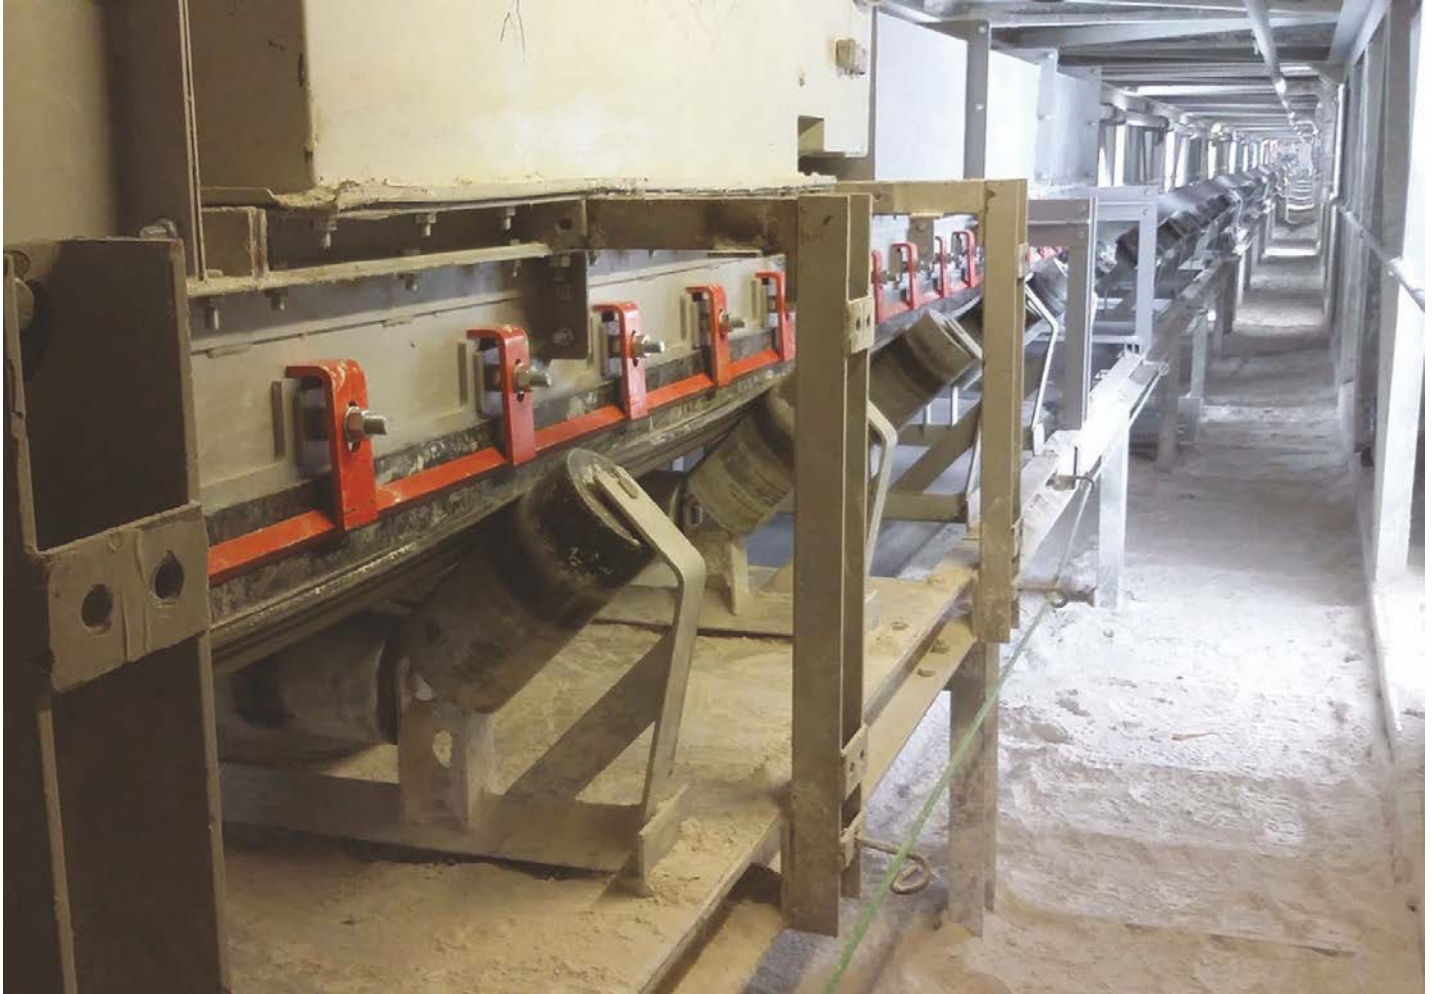
Skirt sealing contains small lumps and fines. ▲

Placed flush with the wear liner on the outside of the chute, the ApronSeal includes a primary and secondary sealing strip with a dual-sided elastomer construction made of 70 durometer EPDM rubber composite for its low abrasion index characteristics. The primary strip holds a tight seal on the belt to trap fugitive dust and contain it within the cargo flow. The self-adjusting secondary seal rides smoothly on the belt alongside the rigid primary strip to provide an extra dust seal. Once the contact area of the sealing strip has worn down, workers merely loosen the mounting brackets, slide the strip out and flip it over, doubling its wear life.

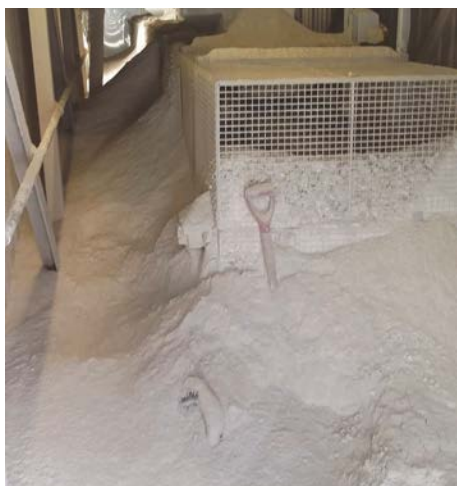
fire hazard. Dust would quickly build up around the loading zone and encapsulate the tail pulley, eventually causing the belt to just slide over the built-up material rather than riding on the rollers, which fouled the return side of the belt and the face of the tail pulley. Fugitive material would travel freely throughout the long shaft, piling up and restricting access for maintenance workers to address these issues.

Piled high enough to encapsulate the tail pulley and belt, the dust was a serious problem. ▼

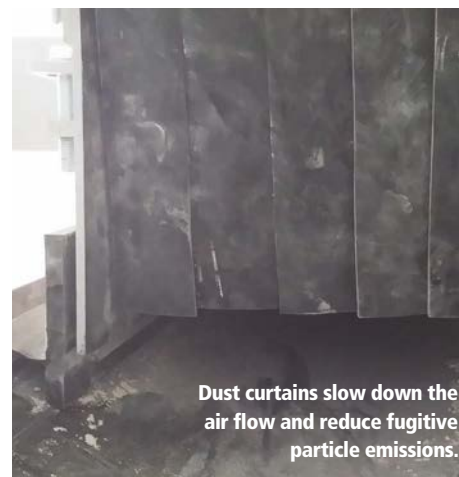
Dust curtains slow down the air flow and reduce fugitive particle emissions.

Following the loading zone, several dust curtains stop dust from escaping out of the end of the chute by trapping it within the settling zone. Previously, the mechanical dust filtration systems had been unable to handle the sheer volume of particulate matter, so the filters clogged quickly and created a maintenance issue, causing the units to be abandoned. With the units operational again, technicians cleaned the area and replaced the filters. Combined with the new chute design, the

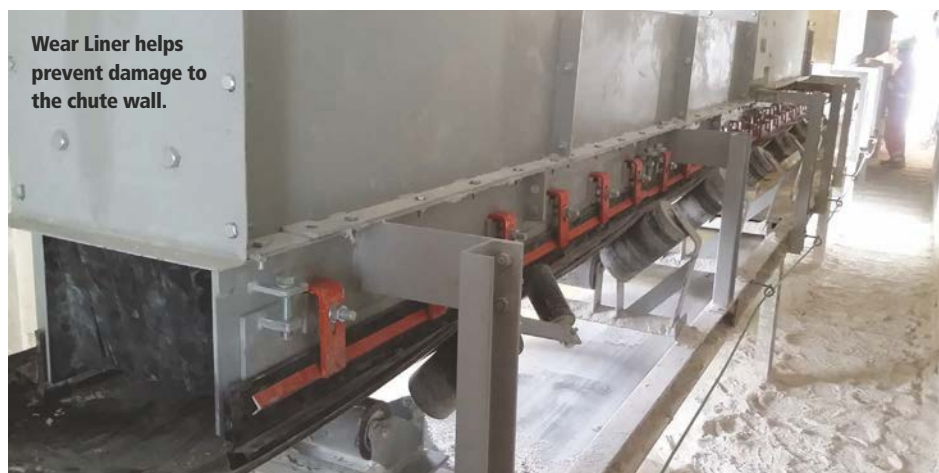
Wear Liner helps prevent damage to the chute wall.

The new design raised the chute 102 mm (4 in.) from its previous position to accommodate the EVO External Wear Liner. Mounting brackets with jackscrews provide a secure mount, with

precision adjustment of the wear liner to reduce spillage. This system closes the gap between the liner and the sealer, thus eliminating abrasion from trapped material without interfering with existing supports. When accompanied by the Double Sided ApronSeal skirting and clamps, the system forms a tight belt seal, delivering outstanding fugitive material control.

The special mounting tabs allow the liner to be both adjustable and replaceable from outside the chute, requiring no confined space entry. Maintenance staff merely need to loosen the mounting tabs and remove the wear liner, then slide the new one in. This reduces the replacement procedure to a fraction of the time and makes the operation significantly safer, with far less downtime.
