WORLD CEMENT[®]

A Breath of Fresh Air

BRAD PRONSCHINSKE,
MARTIN ENGINEERING, USA, LOOKS
AT HOW REPOSITIONING CLINKER
COOLER AIR CANNONS CAN LEAD
TO SAFER MAINTENANCE AND
LONGER EQUIPMENT LIFE.

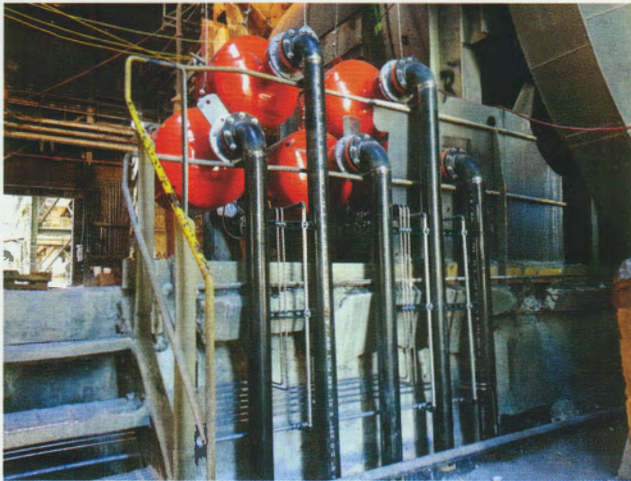
4.5 in. (11.5 mm) pipes lead down to holes drilled into the concrete floor, then continue under the subfloor.

Completed over a week by a team of four people during scheduled plant downtime, the design lifted the cannons away from the discharge area and up to a pre-existing platform several meters away. Five cannons were connected to five U-shaped pipes that curved 90° from the cannon, and ran vertically 10 ft. (3 m) down, through holes drilled into the concrete floor of the plant's cooler maintenance platform. They then curved 90° again, and travelled horizontally for 20 ft. (6 m) under the platform to the kiln's discharge area, where they split toward different entry ports for maximum coverage. Special nozzles made out of refractory material, purchased by Lehigh operators from a refractory supplier, distributed the surge of air toward the areas of likely buildup.

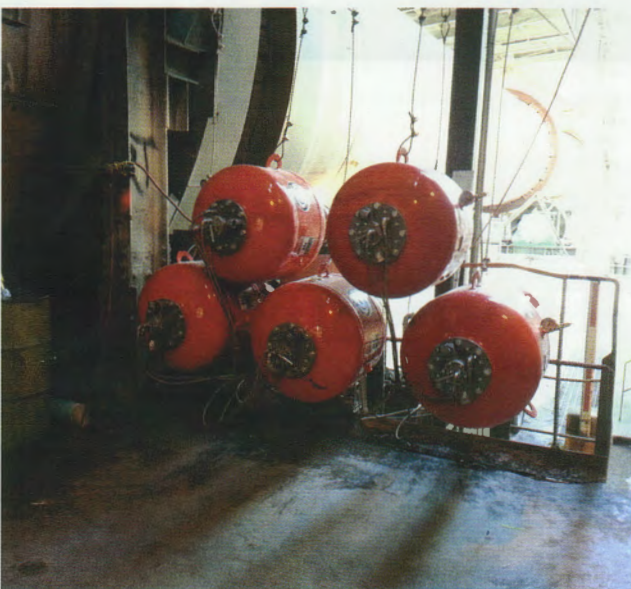
Valves face outward for convenient maintenance, requiring no tank removal to service them.

The Hurricane's valve faces outward, opposite the pipe end, and is serviced without removing the cannon tank. A single technician simply detaches the air and solenoid connections, removes the eight bolts from the valve assembly, and slides it out for inspection and maintenance.

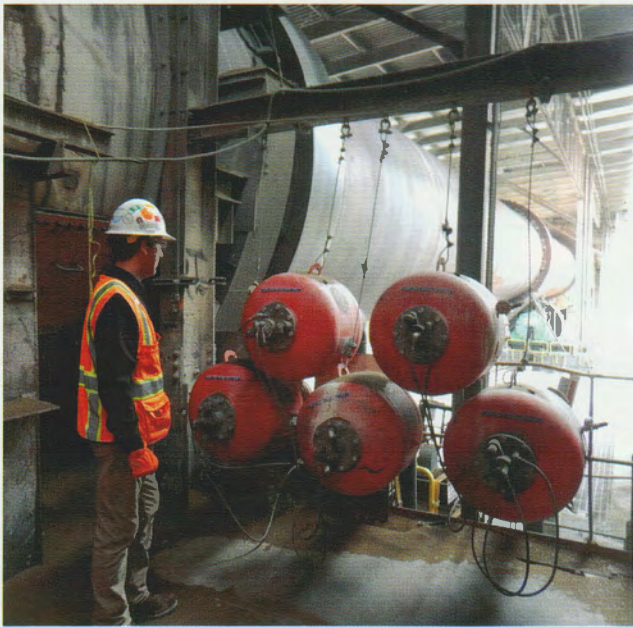
Workers are able to access the tanks in a safe and comfortable area, with ample room to work.

By moving the cannons away from the hazardous area, the lack of heat exposure has reduced the impact on the equipment itself, increasing the life of the valves and the tank. Setting the tanks in an easily accessible and safe area, means that workers can inspect the equipment more often and perform maintenance on a single cannon without downtime.

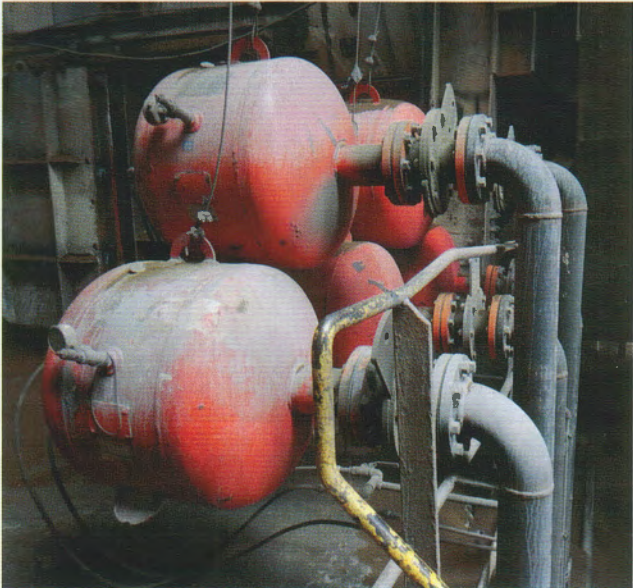
After five years of service, the cannons continue to operate at a high level of reliability.

"After five years of constant operation, the results have been better than we ever expected," said Schutt. "Since installation, we have had a significant reduction in downtime due to snowman formation. Not having to get near the hot wall or put on special equipment has definitely made a difference in the morale of the maintenance and production staff."
