Total discharge: clean belt, clear chute

Dan Marshall, Martin Engineering, offers recommendations on the best practices that can help operators avoid common inefficiencies at their discharge zone.

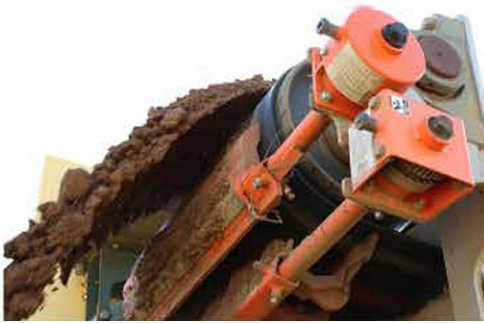
Figure 1. Discharge from the belt no longer needs to be a dirty and dusty process.

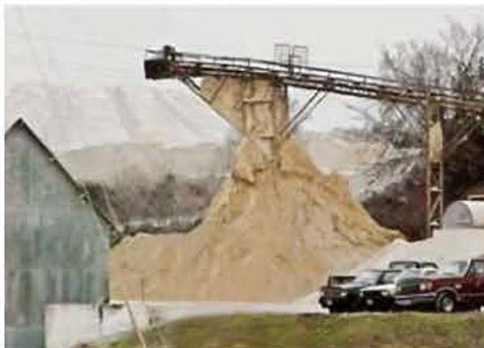
Figure 2. Sand spillage reaching up to the discharge point on a stacker conveyor.

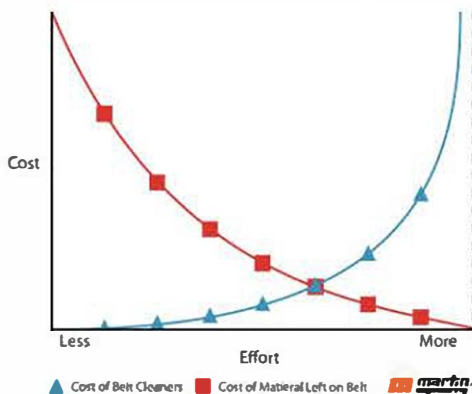
Cost vs. Effort for Cleanup in Discharge Zones

Figure 3. The cost of cleanup and improved safety justify the expense of a well-designed discharge solution.

Cleaning spillages can be costly, divert staff from other essential duties, and become a workplace safety issue if workers are clearing material around a running belt (Figure 3). What may seem like a routine job in the beginning, clearing spillage by either shovelling it back into the cargo stream or into bins, requires more labour as time goes on and the problem worsens. Clearing material using machinery (front loaders, industrial vacuums, etc.) can

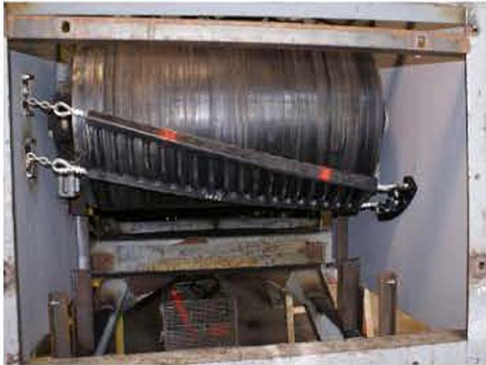
Figure 4. Innovative new cleaner designs require less monitoring and no tensioning.

Enter a service agreement with the blade manufacturer to regularly monitor, tension, and change the blades as needed. Consider installing a modern assembly that allows workers to slide units from the stringer for fast and easy one-person blade changes. There is also the option of using an innovative cleaner technology with 4 times the lifespan of the normal primary blade and needs no tensioning over the course the blade's use (Figure 4).

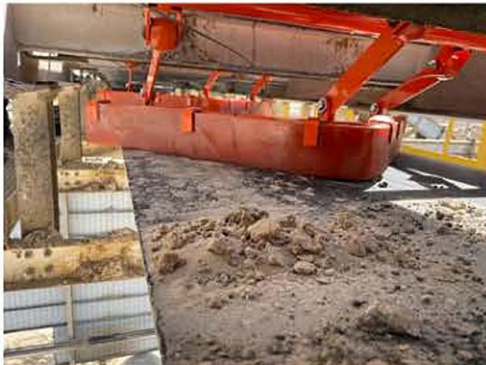
Figure 5. The V-plow diverts fugitive carryback to either side of the system, ensuring tail pulley health.

tail pulley that rides on the underside of the belt removing any loose travelling material (Figure 5). For more effective cleaning and reduced friction damage, consider a plow with torsion arms rather than one held in place by chains. Install belt trackers or crown rollers along the upper and lower belt paths to ensure alignment.

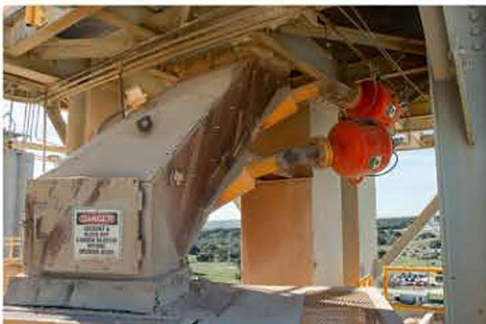
Figure 6. The direction of the cannon shot matches the stream trajectory to encourage constant flow.

Air cannons strategically installed around the chute have nozzles pointed in the direction of the material flow. Powerful shots of air are distributed across the surface inside the vessel, dislodging material and preventing buildup. The air cannons are supported by vibration units that ensure gates and narrow spouts on hoppers and chutes retain proper flow before bridging starts. In many cases, vibration alone can handle most dry material flow but changes in humidity raising the stickiness of cargo and chute surfaces, along with fluctuations in production volumes, are much better handled by air cannons (Figure 6).

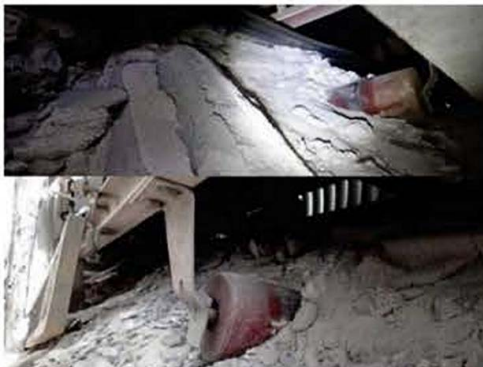
Figure 8. The roller is encapsulated by spillage at the discharge zone.

A cement plant located in Western Ukraine was experiencing extensive carryback on conveyors carrying slag. Due to the abrasive material's particle shape and small size, it easily passed under the cleaner blade and remained on the return side of the belt, allowing it to drop along the belt path. Fugitive material built up on floors and encapsulated rolling components, causing excessive downtime for maintenance and cleaning (Figure 8).

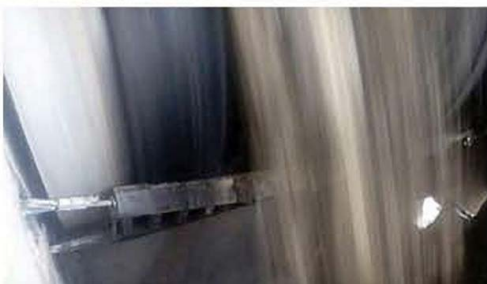
Figure 9. Cleaning the belt of dust and fines with a few telltale streaks on the belt denoting carryback.

contact pressure between belt and cleaner. The blade is comprised of a matrix of tungsten carbide scrapers and is tensioned against the belt by stringers, typically resulting in the removal of as much as 95% of difficult material. Engineered for belt widths up to 120 in. (up to 3000 mm), speeds up to 1500 fpm (7.5 m/s), and pulley diameters of up to 78 in. (2000 mm), the blade delivers double the life of most standard blades (Figure 9).
