# WORLD COAL<sup>®</sup>

# PREVENTING

# WEAR

# & TEAR

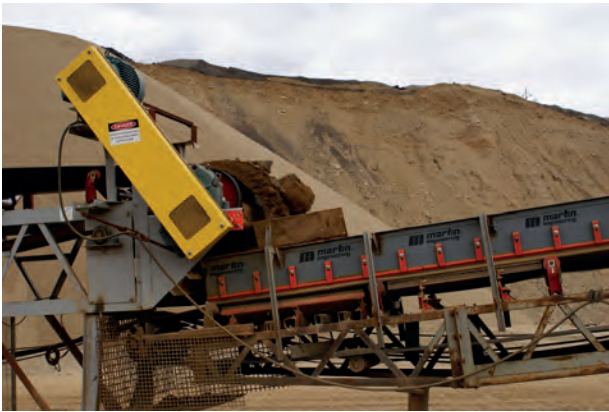
**Figure 1.** Impact cradles and support cradles are linked by transition rollers to avoid belt sag and retain the seal.

Martin engineers devised a heavy-duty impact cradle that supports the belt and absorbs the impact of loaded material in a consistently sealed environment (Figure 1). In contrast, impact idlers can leave unsupported gaps between idlers where dust and spillage can escape. Additionally, the bearings and rollers can misshapen over time, reducing the efficiency and safety of the conveyor system. Impact cradles are specially designed with a top layer of slick ultra-high-molecular-weight polyethylene (UHMW) moulded to a base of impact-absorbing styrene-butadiene rubber (SBR). The belt slides across them easily with little friction, while the bars give enough shock support that the belt is not damaged from precise hits on sharp edges. By eliminating the gaps between idlers, skirting creates a tight seal against bars, further reducing the amount of fugitive dust and spillage for more compliant and safer operations.

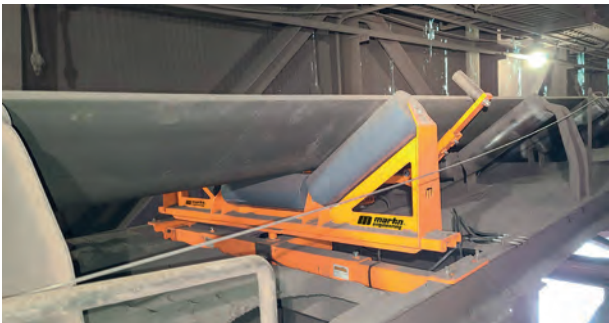
**Figure 2.** The tracker reacts the moment the belt drifts to make slight adjustments.

The heavy-duty tracker uses sensing rollers that ride on either side of the belt edge and detect slight variations in the belt path. Triggered by the force of a wandering belt, the sensing rollers automatically position a pivoting idler in the opposite direction of the misalignment. The lever action requires less

force to initiate the correction, so slight adjustments retain consistent contact between the belt and idlers and require less energy to realign the belt. Strategically placing units along the carrying side and return side ensures a true belt path through the entire rotation regardless of load shifts (Figure 2).

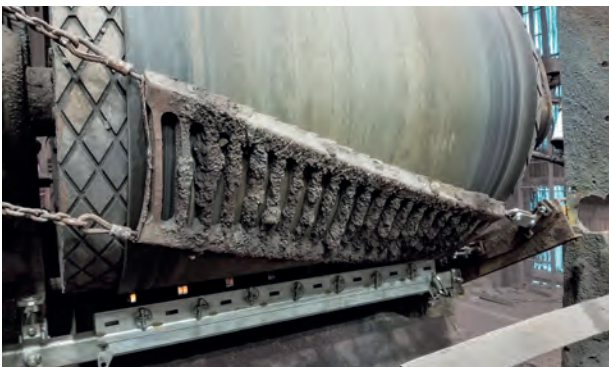
**Figure 3.** Offering edge-to-edge coverage, new cleaner designs are more resilient in punishing environments.

New designs in heavy-duty belt cleaners have reimagined the approach to cleaner technology. The innovative design incorporates a matrix of tungsten carbide scrapers installed in a three-dimensional helix angle across the face of the discharge pulley. It is tensioned lightly against the belt to prevent damage to the belt or splices and requires no re-tensioning after installation for the life of the blade. Despite extremely low contact pressure, field tests have revealed the unique blade design to have significantly superior results over standard primary cleaners (Figure 3).

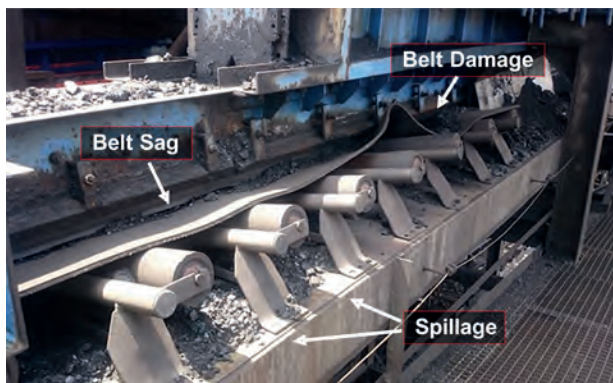
**Figure 4.** Broken equipment, spillage, and improper idler spacing all culminated in expensive consequences.

A coal mine in Eastern South Africa producing 3.1 million tpy of coal was experiencing heavy spillage and system damage along the length of a main conveyor due to inadequate loading zone equipment. Impact idlers allowed excessive belt sag, causing high volumes of spillage. Dust and fines fouled idlers, and rocks became lodged between the belt and the skirt, resulting in unscheduled downtime due to frequent equipment failures and

chute liner replacements. Material that had built up threatened to encapsulate the belt return, so labour was diverted for cleanup, further raising operating costs (Figure 4).
