TEXT Dave Harasym, UK Sales Manager, Martin Engineering, Nottingham/UK

Controlling fugitive dust emissions on limestone conveyor transfer point

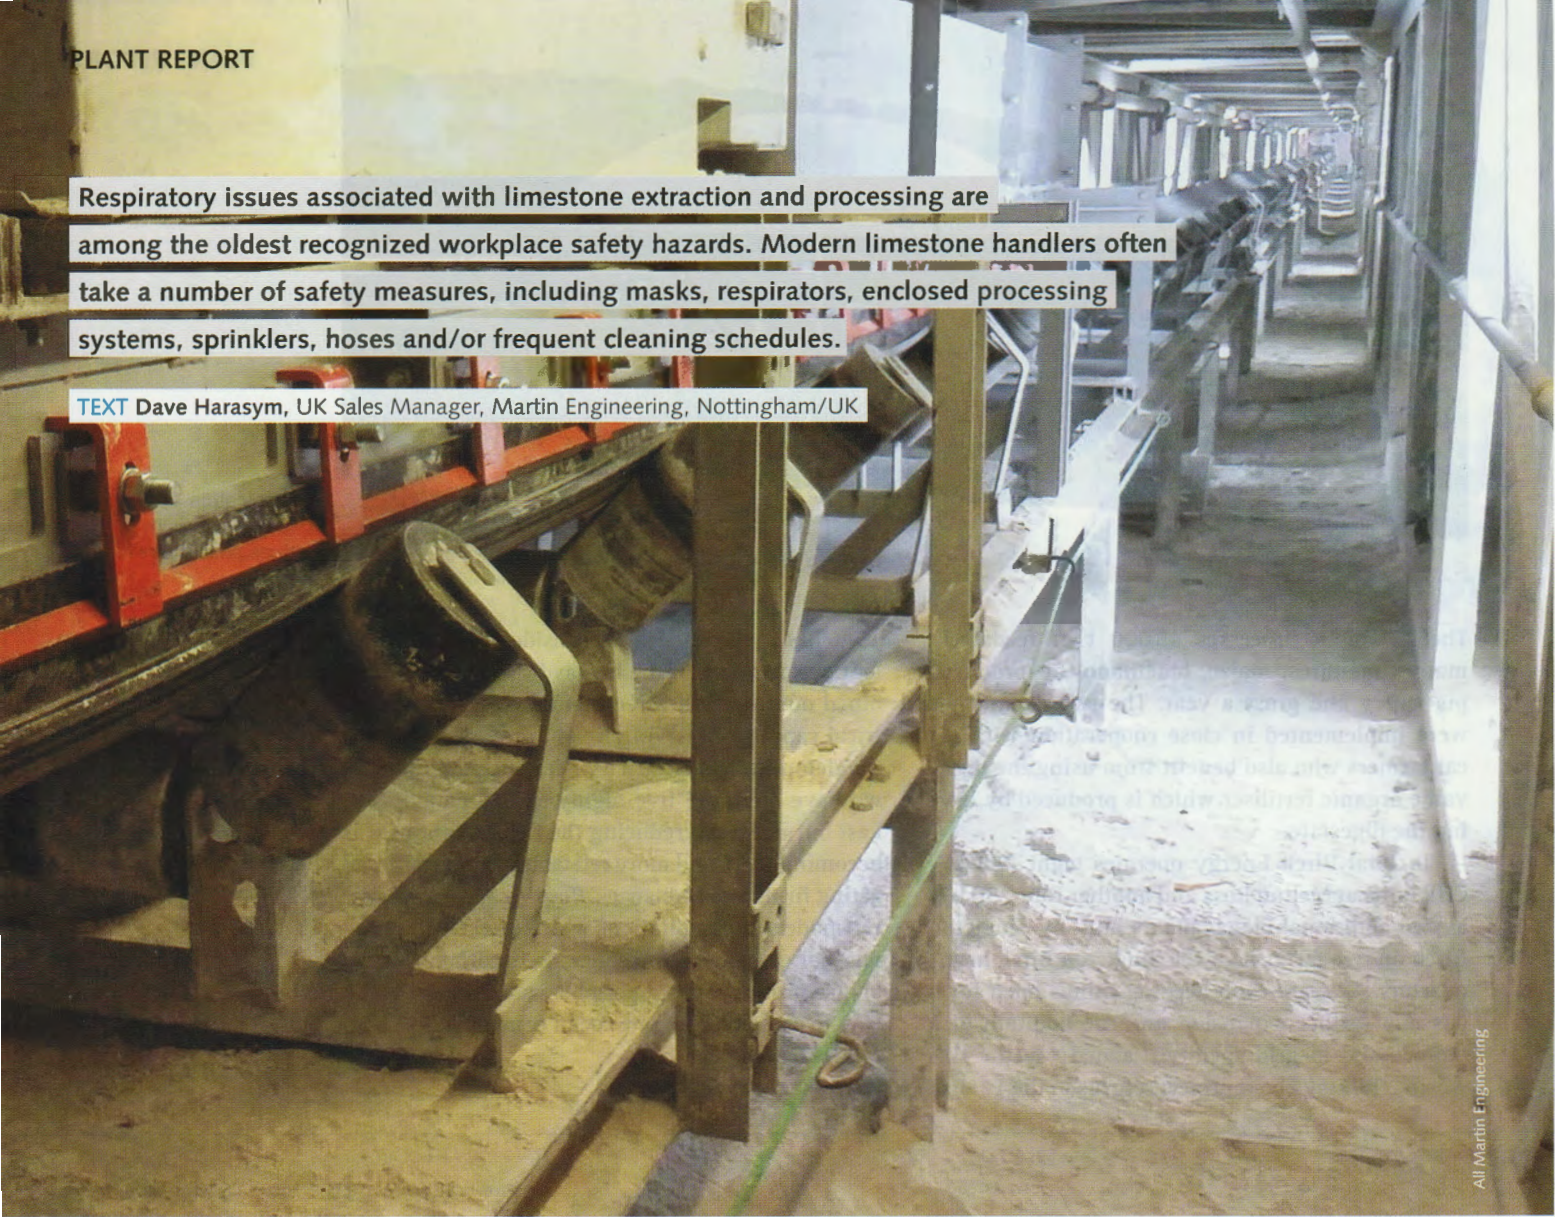
ApronSeal Skirting contains small lumps and fines

Placed flush with the wear liner on the outside of the chute, the ApronSeal includes a primary and secondary sealing strip with a dual-sided elastomer construction made of 70 durometer EPDM rubber composite for its low abrasion index characteristics. The primary strip holds a tight seal on the belt to trap fugitive dust and contain it within the cargo flow. The self-adjusting secondary seal rides smoothly on the belt alongside the rigid primary strip to provide an extra dust seal. Once the contact area of the sealing strip has worn down, workers merely loosen the mounting brackets, slide the strip out and flip it over, doubling its wear life.

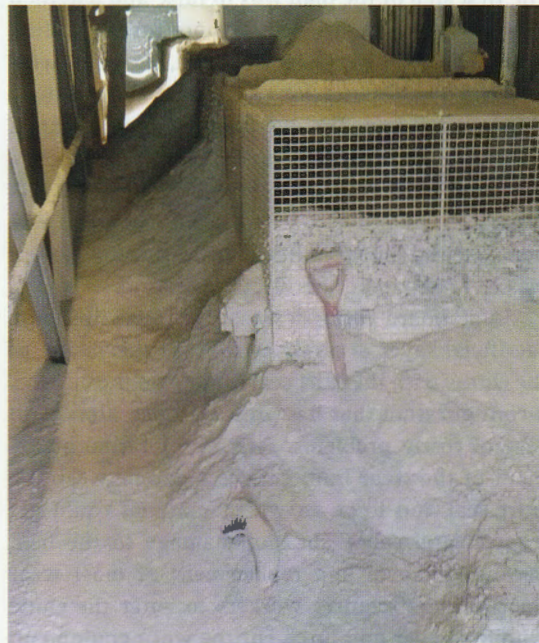
1 Piled high enough to encapsulate the tail pulley and belt, the dust was a serious problem

Although the enclosure confined the fugitive dust, many serious issues arose due to the sheer volume and density of the particles. Abrasive material would get into the bearings of rolling components and cause them to seize up, leading to increased friction on the belt – a potential fire hazard. Dust would quickly build up around the loading zone and encapsulate the tail pulley, eventually causing the belt to just slide over the built-up material rather than riding on the rollers, which fouled the return side of the belt and the face of the tail pulley. Fugitive material would travel freely throughout the long shaft, piling up and restricting access for maintenance workers to address these issues.

According to Whelpton, to maintain normal operation of the system and avoid serious hazards, the area needed to be cleaned by two workers once per week, requiring nearly an entire shift. Before engaging in what he described as a “substantial undertaking,” the system would be shut down so that workers could see. Anyone entering the enclosed area was required to wear personal protective equipment (PPE), including breathing masks with respirators and hooded suits to protect against airborne particles. Workers first had to clear thigh-deep piles of dust from walkways and around the mainframe using the plant’s central industrial vacuum system, in order to access the conveyor for inspection and maintenance.

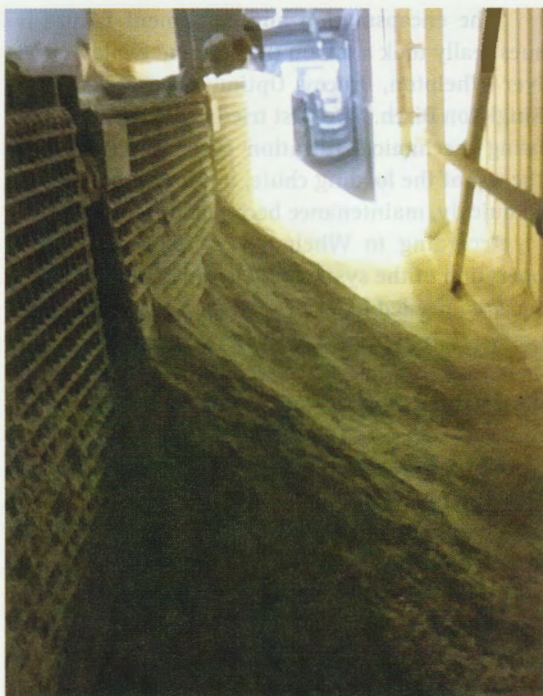
2 Dust blocked walkways and posed a potential safety risk

According to Whelpton, spillage and accumulation along walkways and around the mainframe has been eliminated. There has been no encapsulation of the belt or tail pulley since installation, and rolling components are far less prone to fouling due to dust and spillage. Protective suits are no longer required for people to enter the area, as they need only PPE masks to protect against trace particles emitted through normal operation. “This has led to a morale boost for the plant staff,” he pointed

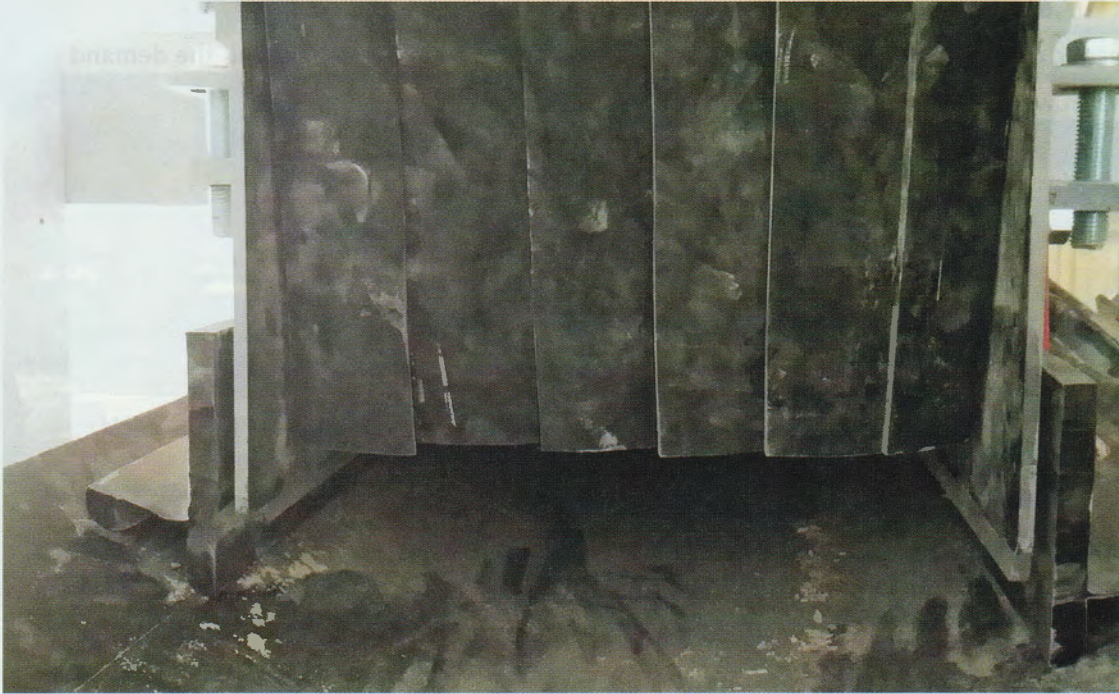
3 Dust curtains are set throughout the chute to slow air flow and reduce fugitive particle emissions

Following the loading zone, several dust curtains stop dust from escaping out of the end of the chute by trapping it within the settling zone. Previously, the mechanical dust filtration systems had been unable to handle the sheer volume of particulate matter, so the filters clogged quickly and created a maintenance burden, causing the units to be abandoned. With the units operational again, technicians cleaned the area and replaced the filters. Combined with the new chute design, the systems are able to effectively filter any overflow of dust.

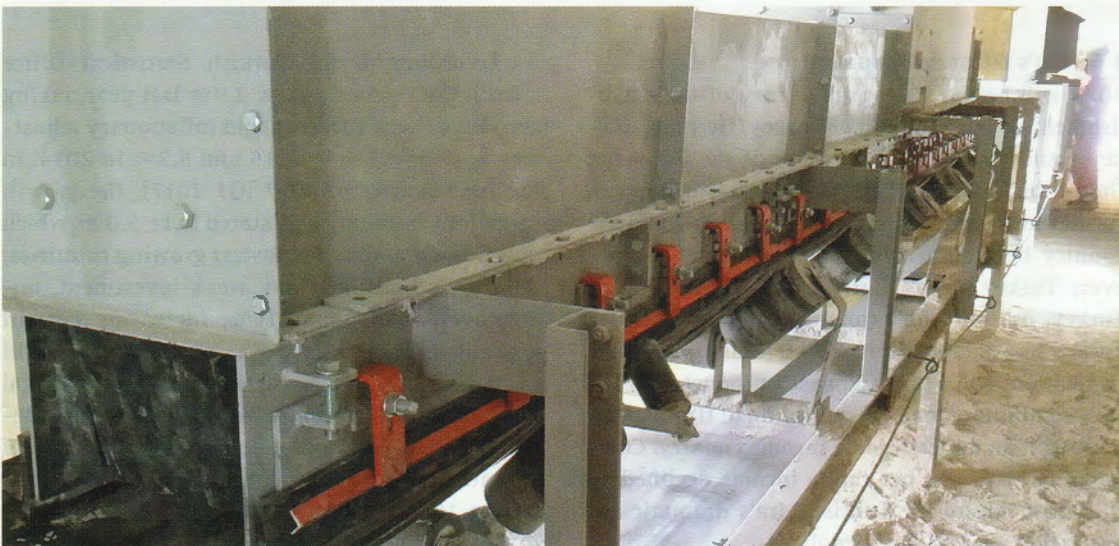
4 The EVO External Wear Liner helps prevent damage to the chute wall

The new design raised the chute 102 mm (4 in.) from its previous position to accommodate the EVO External Wear Liner. Mounting brackets with jackscrews provide a secure mount, with precision adjustment of the wear liner to reduce spillage. This system closes the gap between the liner and the sealer, thus eliminating abrasion from trapped material without interfering with existing supports. When accompanied by the Double Sided ApronSeal skirting and clamps, the system forms a tight belt seal, delivering outstanding fugitive material control.

The special mounting tabs allow the liner to be both adjustable and replaceable from outside the chute, requiring no confined space entry. Maintenance staff merely need to loosen the mounting tabs and remove the wear liner, then slide the new one in. This reduces the replacement procedure to a fraction of the time and makes the operation significantly safer, with far less downtime.
