ZKG

TEXT Dave Mueller, Product Manager, Martin Engineering

Conveyor dust and spillage: The importance of Skirtboard Sealing Systems

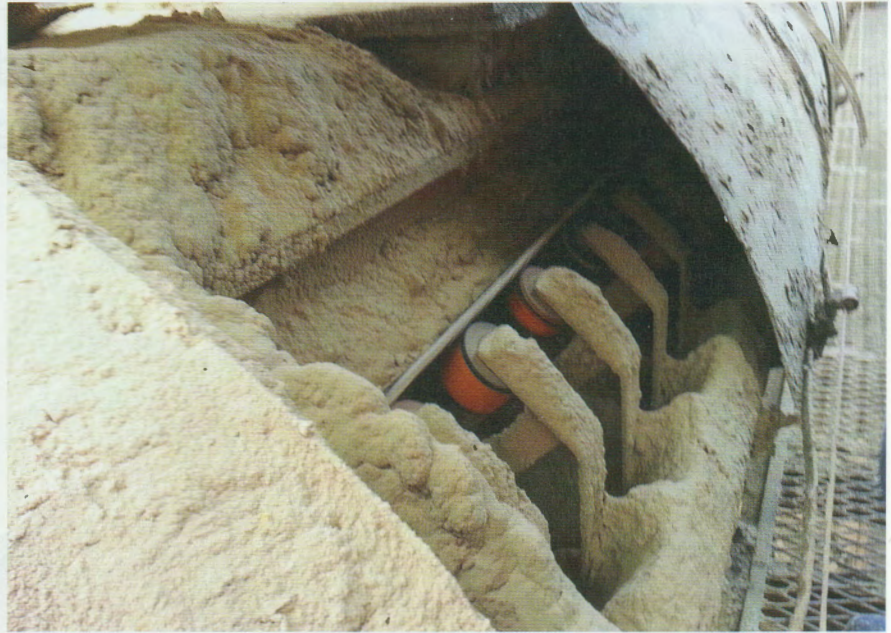
4 Dust and spillage clogs idlers, requiring them to be replaced and raising the cost of operation

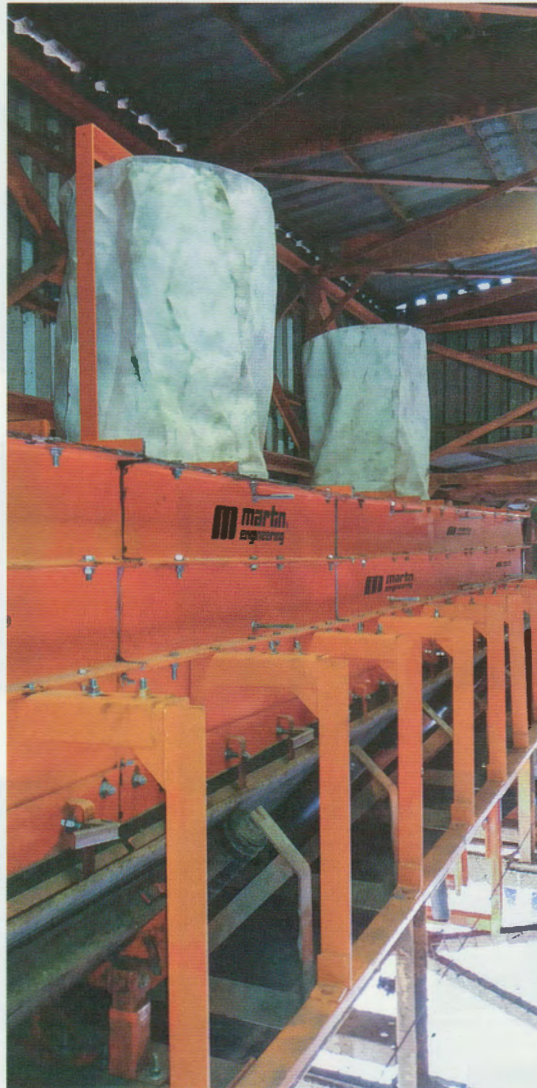
5 The new loading zone featured a sealing system that mitigated spillage and dust supported by dust bags

Martin Engineering technicians constructed a longer sealed enclosure with the ability to control airflow and give dust extra space to settle. They added several other critical components including external dual seal skirtboard and wear liner system. Impact cradles and slider cradles replaced the idlers to seal gaps in the chute.
