ZKG

TEXT Dave Mueller, Senior Product Specialist, Martin Engineering, Neponset/USA

Innovative technology eliminates carryback on cement grinding conveyor

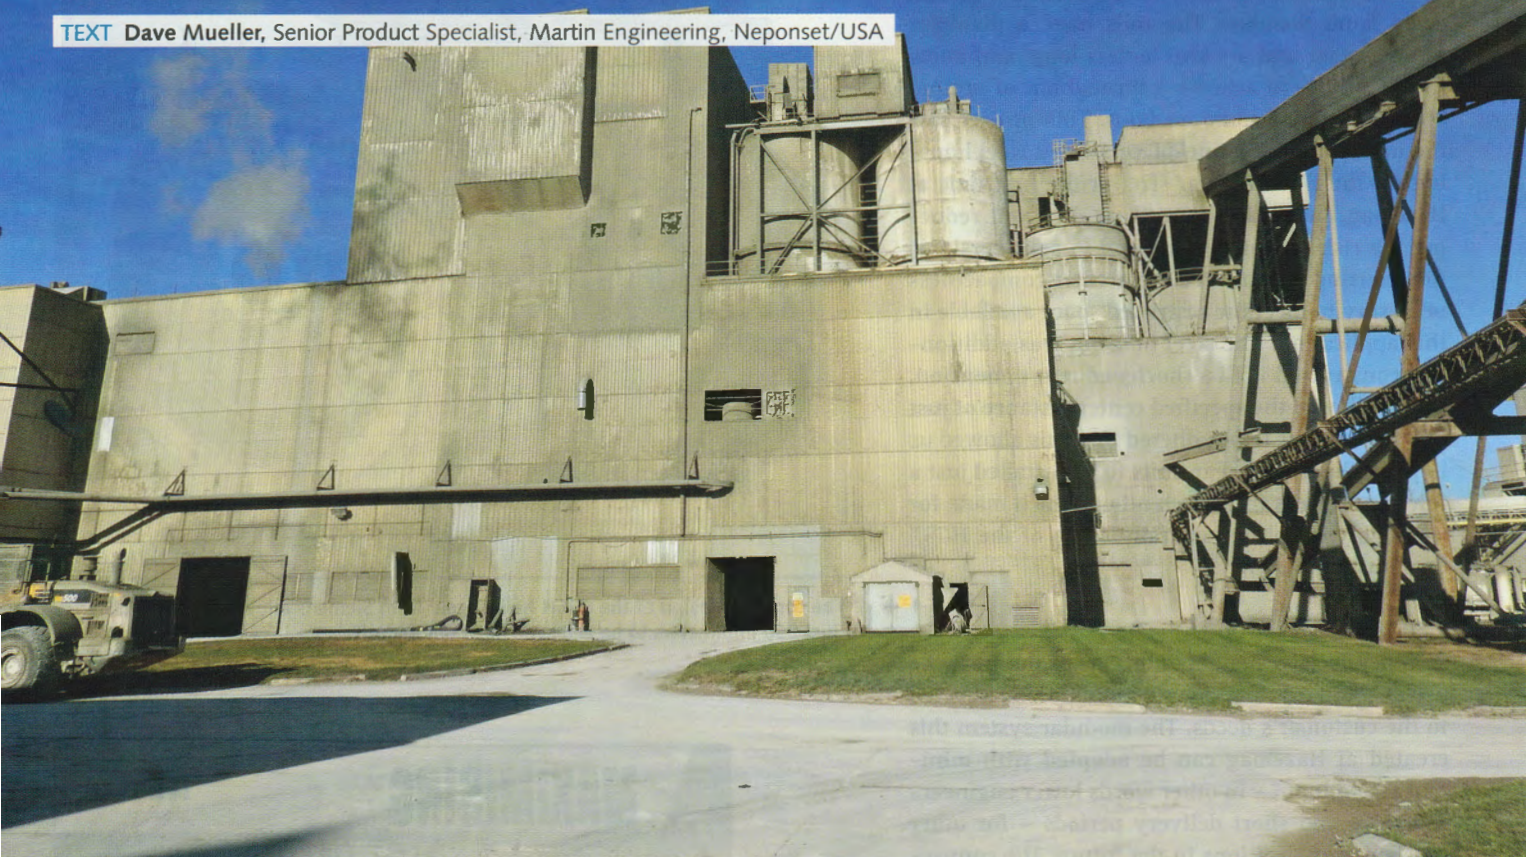
1 Conveyors transporting bulk materials have different entry points into the plant

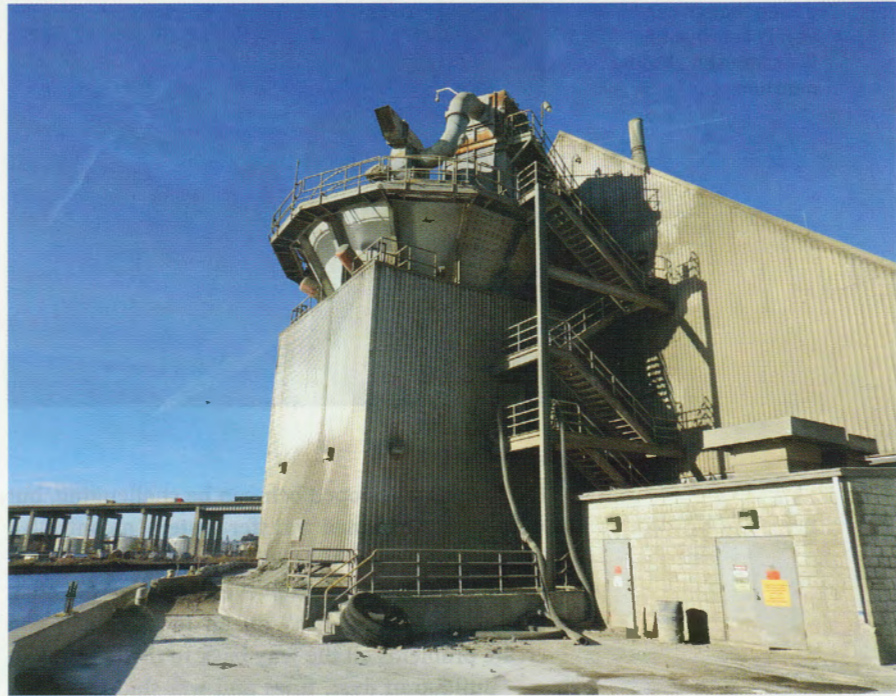
2 River barges dock several times a day to drop off raw materials

Roughly 30000 t (27215 mt) of raw material and clinker arrives weekly by truck and ship. The clinker is housed in a large shelter, while the raw aggregate is offloaded to an outdoor storage area, where the material tends to get saturated when the Michigan weather turns wet and cold. This causes large amounts of mud and sludge to be loaded along with aggregate into the chute leading to the #14 belt. Even though the conveyor system is partially covered with a hood along the entire belt path, cargo is still exposed to weather conditions and can dampen further on its way to the discharge zone.

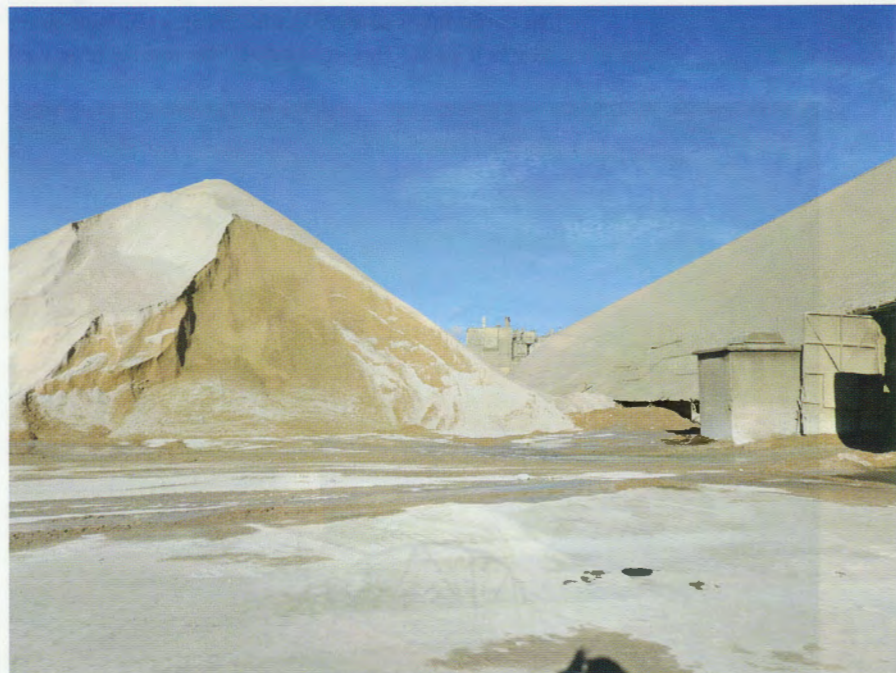
3 Limestone and other raw material is taken from trucks and barges, and stored in outdoor piles

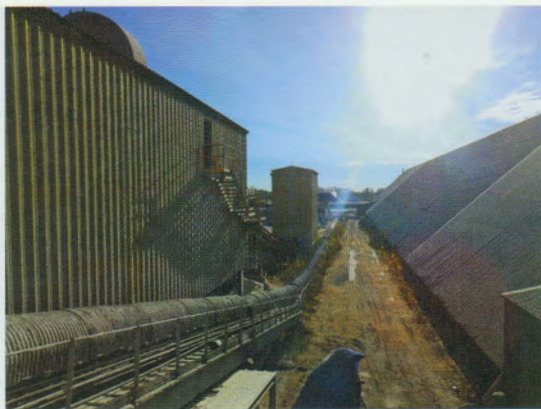
4 Even though conveyors are covered, the cargo still absorbs moisture

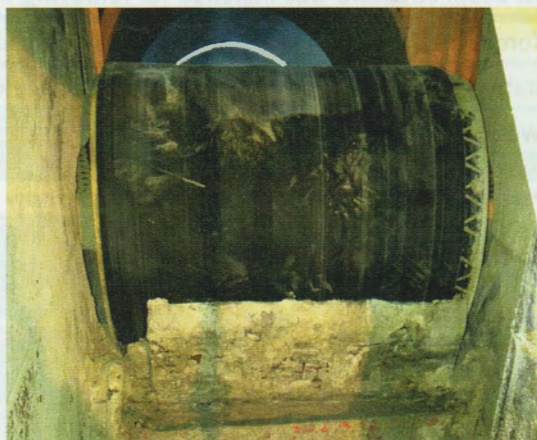
6 The prior blade got encrusted with material, degrading performance and accumulating build-up

Operators found that polyurethane cleaner blades were unable to completely clean the belt. “The fines and mud take on the tacky consistency of toothpaste, causing it to cling to the belt along with smaller pieces of aggregate and shale,” Accomando said. “This led to a lot of carryback spilled along the return path, where it fouled idlers and built up so high on the pan under the loading zone that it would encapsulate the tail pulley.”

To manage the carryback at the discharge zone, workers would need to hose down and hammer off buildup from the belt scraper, as well as clean off the face of the head pulley, which was described as acting like sand paper against the belt. The clean-

er required regular tensioning and periodically needed to be removed, re-cut and shaped. Despite meticulous care of the blade, it needed replacement two or three times per year.

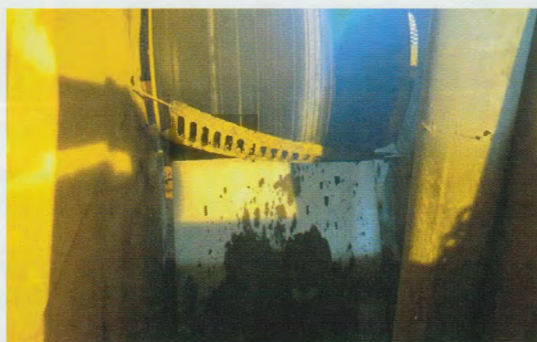
7 Mounted diagonally, commonly at a 17° angle, the CleanScrape spans the entire belt profile

There are many traits that separate the CleanScrape design from conventional urethane blade cleaners. Mounted using an upper and lower chain configuration attached to a Cleaner Tensioner Diverter, the surface spans the entire belt profile. The flexible cleaner is installed diagonally across the discharge pulley, forming a three-dimensional curve beneath the discharge area that conforms to the pulley’s shape.

The unique design incorporates a matrix of tungsten carbide teeth and is tensioned lightly against the belt to prevent damage to the belt or splices. Despite extremely low contact pressure between belt and cleaner, it has been shown to remove as much as 95% of potential carryback material. The low pressure allows the blade to pass over the #14 conveyor’s vulcanized splice without damaging the belt or splice.

Designed for belt speeds up to 780 fpm (4 m/s) for mechanically spliced belts, pulley diameters up to 50 inches (1270 mm), and belt widths up to 96 inches (2438 mm), the CleanScrape is engineered to perform under the punishing conditions of the cement and bulk handling industries. Unlike other cleaners with a rigid mandrel, bulky tensioner or

an unwieldy blade section, the dual chain mounting has a significantly lower installation footprint on the mainframe and a user-friendly design for adjustment, service and replacement, without confined space entry.

Suitable for reversing belts, the CleanScrape is equipped with two breakaway links, allowing the operator side of the cleaner to separate from the tensioners and fall away from the belt. Remaining attached to the far side bracket, this important safety feature prevents damage to the cleaner or conveyor components, so that operators can shut down the system and safely replace the cleaner with minimal downtime.

Perhaps its most valuable feature is the extremely low maintenance it requires. The tensioners are tightened during initial installation and then re-tensioned about a week later. No further adjustment is required over the life of the blade. As the tungsten cleaning surface wears in the direction of belt travel, the cleaner is supported at right angles to the belt, so the wear of the tungsten has no effect on the tension being applied.

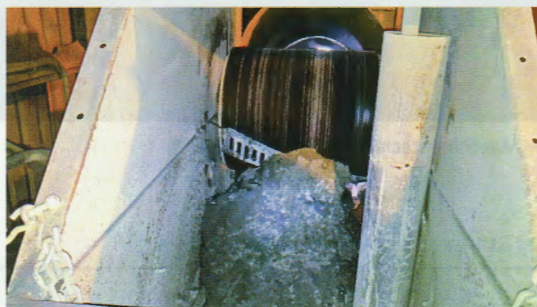
8 The increased flow of material cleared from the belt required a vibrating dribble chute to be installed

With the cleaner system ready for a fresh test, the results were apparent almost immediately. As cargo with a moisture level of 10 to 15% was loaded onto the belt, dust and fines built up into a thick paste as usual, but ended up being fully removed from the belt. After the 30 day trial was concluded, operators discovered the cleaner to be so efficient that it extracted more material than the chute could process, causing it to build up in the chute and back up onto the blade. To address the increased volume of discharge, Martin Engineering technicians returned and installed a Vibrating Dribble Chute to enhance the flow capability of the discharge zone.
