# Martin Marietta controls damage and spillage at limestone conveyor drop points

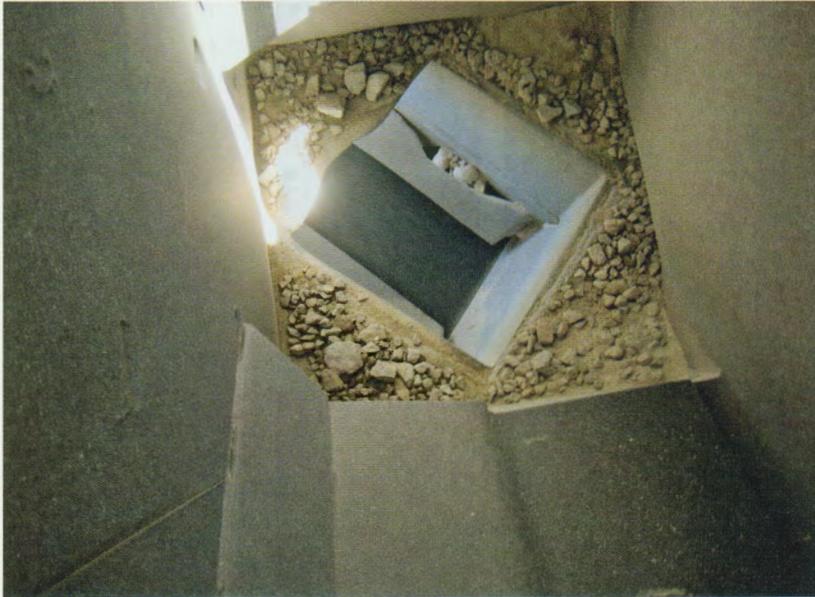
A rock box acts like a shelf, catching and distributing falling material onto the impact cradle

After an analysis, the Martin Engineering team presented a detailed proposal offering a solution that involved several components working in concert to address the belt's issues. The first recommendation was to install a rock box, which works like a series of shelves, catching and distributing the limestone with reduced force onto an impact cradle. Located directly under the chute, the impact cradle is mounted on four rugged steel I-beam supports, able to sustain an impact force of 5443 kg. The specially engineered impact bars are based on an aluminum T-slot design, which is surrounded by a layer of energy-absorbing 83 A durometer urethane and coated with low-friction UHMW plastic to reduce friction and belt fraying.

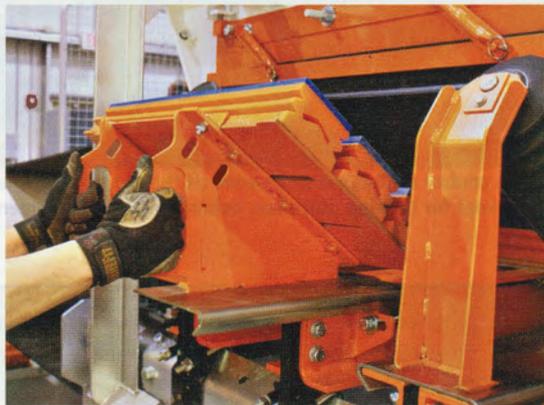
The modular impact cradle absorbs the impact of the falling load, yet slides in and out for easy service

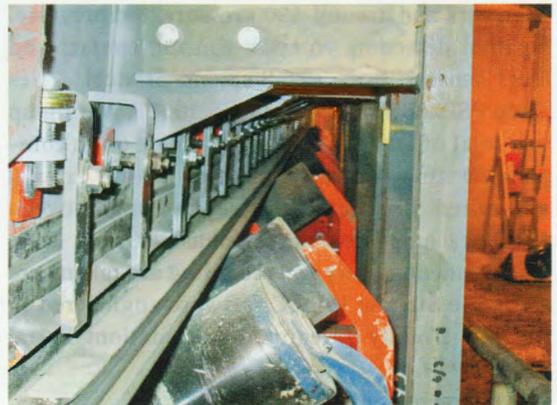
The external skirting system seals the chute to the belt

Following the impact cradle within the 10.3 m settling zone, the team recommended a series of adjustable slider cradles that support the belt to prevent spillage from belt edge sag and to eliminate entrapment points where material commonly got caught. Another key element of the assessment was an external skirting system along the chute box, sealing the chute to the belt. Specially designed to provide dual-seal efficiency with a one-piece 70 Shore D EPDM durometer rubber composite skirt and an attached strip, the skirting floats on the belt and self-adjusts to maintain an effective seal.

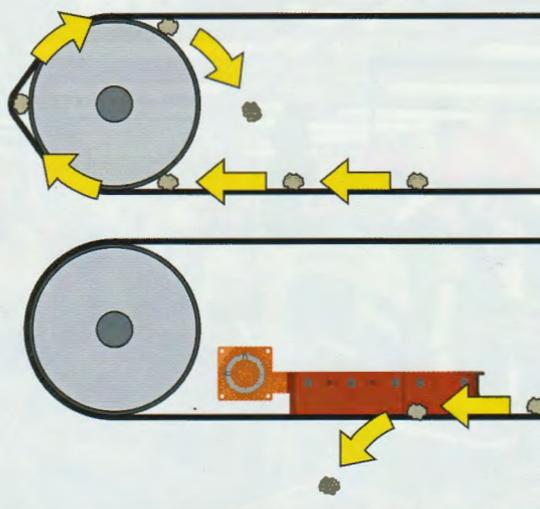
The V-Plow prevents material entrapment between the belt and tail pulley from becoming a repeating phenomenon

Mounted on a dual steel bar attached to the mainframe a few feet from the tail pulley, the V-plow has a unique suspension system that allows the polyurethane blade to rise and fall with fluctuations in belt tension. Any material carried back on the top of the belt return is deflected to either side of the frame before it reaches the tail pulley.
