PROBLEM SOLVED™ PAPER

SOLUTION: Martin® QC1™ Cleaners XHD and DT2H™ Cleaners

INDUSTRY: Gold Mining

LOCATION: Pueblo Viejo Dominicana Corporation, Dominican Republic

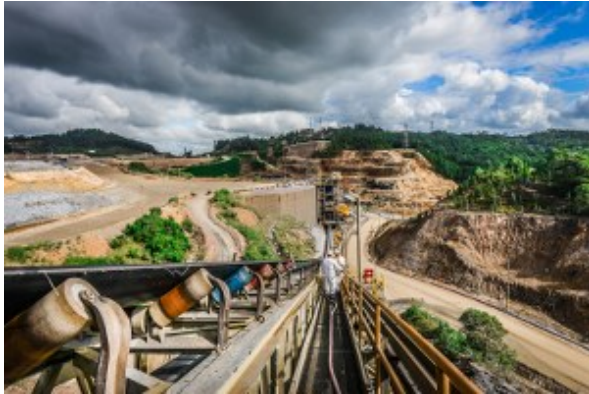
The conveyor system's existing belt cleaners were unable to adequately address the area's overburden.

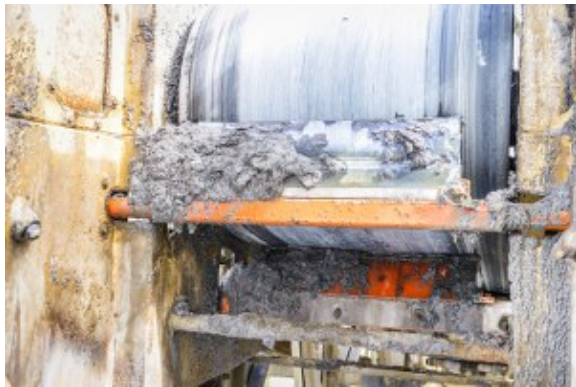
The carryback had the consistency of toothpaste, with chunks of aggregate causing equipment damage.

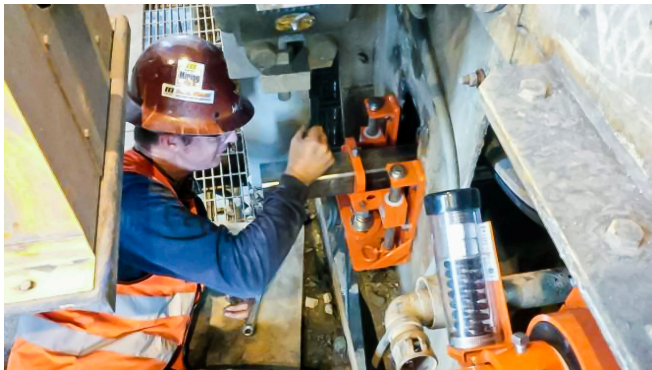
Sixteen belt cleaners were replaced at the discharge points and fitted with low-adhesion urethane blades.

In just two weeks, Martin Engineering technicians replaced the existing belt scrapers with Martin® QC1™ Cleaner XHD primary cleaners and DT2H™ secondary cleaners at 16 locations. Installers fitted them with low-adhesion urethane blades specifically designed for tacky material loads. Both primary and secondary blades can endure high summer temperatures, high moisture and constant production schedules. To avoid product loss, the Martin Engineering team also installed 300 feet of ApronSeal™ Skirting along the belt edges. In addition, Martin Engineering trained a team to recognize potential problems throughout the entire conveyor system and either fix the issues or offer recommendations.
