PROBLEM SOLVED™ PAPER

SOLUTION: Martin® ApronSeal™ Skirting, Martin® Impact Cradles, Martin® Slider Cradles, Martin® Conveyor Guards

INDUSTRY: Cement

LOCATION: Cement Plant in France

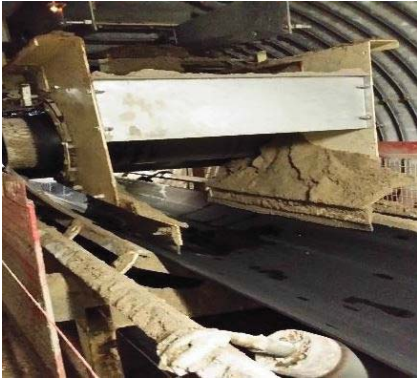
A cement plant on a site in the Rhône, was experiencing excessive spillage from one of its conveyor belts. The material was a mix of sand and water. Every time the extractor started, a mixture of sand and water discharges and the conveyor belt could not contain the material, in its current design.

A cement plant on a site in the Rhône, was experiencing excessive spillage from one of its conveyor belts.

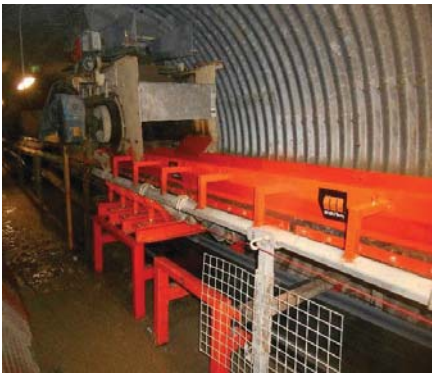
Martin recommended a complete upgrade of the transfer points.

Martin Engineering was called to inspect the system. Martin recommended a complete upgrade of the transfer points. Martin® ApronSeal™ Skirting was added to contain and guide the product along the belt. Martin® ApronSeal™ Skirting floats on the belt and self-adjusts to maintain an effective seal without maintenance. Martin® Impact Cradles were installed under the belt conveyor loading zone to absorb the force of falling material to prevent damage to the belt and structure and to help eliminate spillage. Martin® Slider Cradles were then installed under the skirtboard of a transfer point. Martin® Slider Cradles support the edges of the belt to eliminate sag and by stabilizing the belt's path and allow the effective sealing of the belt edge. Finally, Martin® Conveyor Guards were added to provide a safety barrier and prevent worker exposure to conveyor nip points and pinch point hazards.

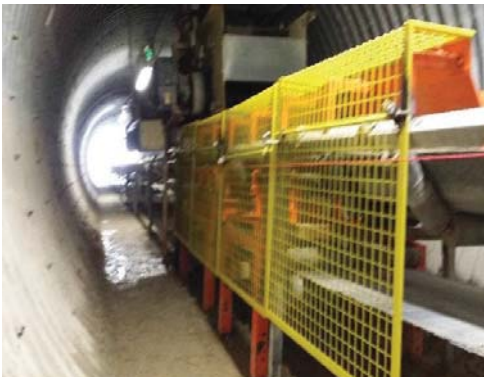
Martin® Conveyor Guards were added to protect workers from conveyor nip points and pinch point hazards.
