PROBLEM SOLVED™ PAPER

SOLUTION: Belt Support, Belt Sealing, Dust Management & Tail Protection

INDUSTRY: Pulp & Paper

LOCATION: Paper Plant in Southern US

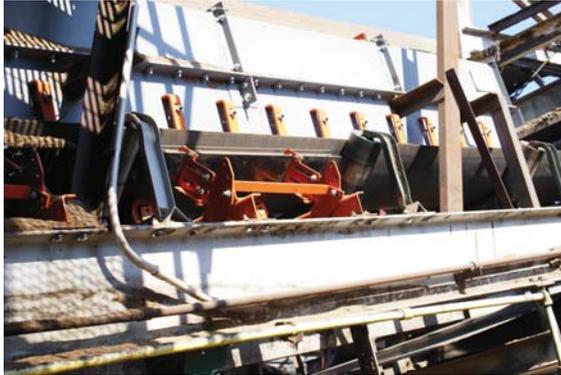
Martin® Belt Support Systems prevent damage to the belt and structure while eliminating spillage.

The plant was currently using an on-site contractor that did not specialize in transfer point work. They also had slider beds fabricated but they did not address the belt support problem. After inspecting the current system for opportunities for improvement, Martin recommended installing belt support and belt sealing systems to help keep material on the belt. Martin supplied EVO® External Wear Liner, Martin® ApronSeal™ Double Skirting, impact and non-impact Martin® Trac-Mount™ Idlers, EVO® Modular Chute Walls, multiple Martin® Dust Curtains and a Martin® Tail Sealing Box. One of the last upgrades Martin made was installing an all-new standard transfer point.

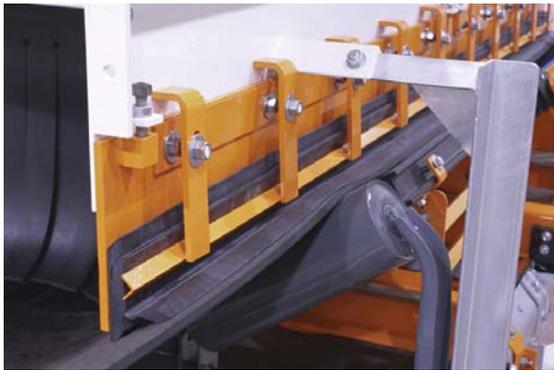
Martin® ApronSeal™ Skirting floats on the belt and self-adjusts to maintain an effective seal without maintenance.
