PROBLEM SOLVED™ PAPER

SOLUTION: Transfer Point Redesign

INDUSTRY: Aggregate

LOCATION: Quarry in Southeastern US

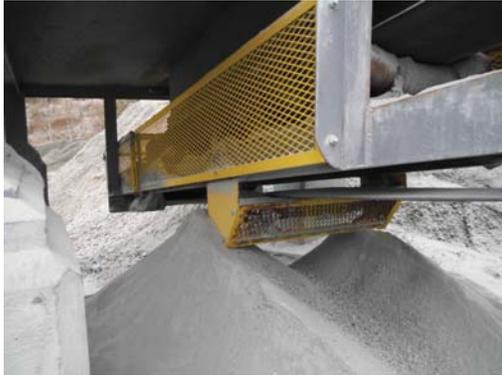
Spillage and dust were becoming constant sources of concern and burden for this Southeastern plant. Their existing transfer chute was not designed within Conveyor Equipment Manufacturers Association (CEMA) specifications and therefore was causing excessive material spillage and airborne dust. Handling 20,000 Tons of crushed rock per month put them at huge risk for material and profit loss. The plant estimated they were losing several thousands of dollars in labor expenses every week! Cleanup was not only an expensive maintenance task but also a dangerous one. Airborne dust can garner negative attention from regulatory agencies and lead to fines. Looking for a cleaner and safer solution to their dust and spillage problems, the plant contacted Martin Engineering.

Before Martin Engineering's transfer point upgrade, the plant encountered significant spillage.

Martin Engineering recommended a complete redesign of the transfer point to accommodate the necessary equipment. The chute was installed from the crusher to the belt. Belt support systems were added so the wear liner could be as close to the belt as possible and within CEMA specifications, ensuring elimination of spillage and reduction of dust from the generated and displaced air from the secondary cone crusher. Martin installed belt sealing systems due to the sloped chutes from the crusher to the conveyor. Martin provided belt alignment and tail protection solutions to keep the belt from wandering and to prevent damage to the belt and tail pulley. The plant provided the material and labor for the chute redesign while Martin supplied installation supervision and the equipment upgrades.

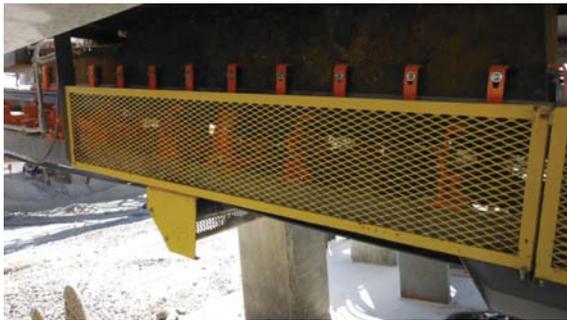
After Martin Engineering's transfer point upgrade, the spillage was eliminated.

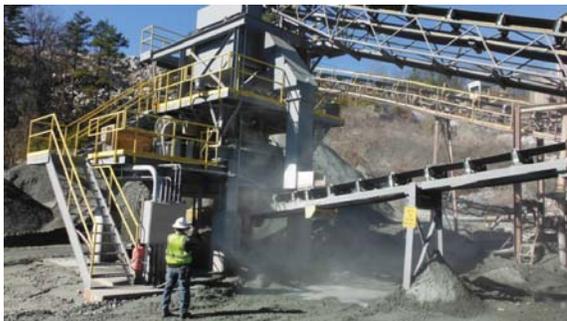
BEFORE: Loader operators used the cloud of dust to determine if the crusher was working properly.
