# PROBLEM SOLVED™ PAPER

**SOLUTION:** Martin® Impact Cradles

**LOCATION:** Johnson Controls (Enertec), Nuevo Leon, Mexico

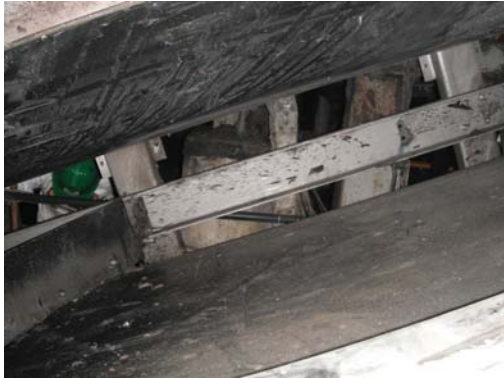
Enertec is dedicated to the recycling of car batteries; they triturate and separate the plastic and lead from the batteries, and then re-use it to manufacture new batteries. Their belt suffered from impact damage and misalignment. Smaller batteries (motorcycle batteries) tended to exit the loading chute because the belt didn't have an effective support system. Some of the batteries ran down the back of the chute, which caused damage to the belt and also to the tail pulley. And others fell down the sides and accumulated between the chute and the conveyor. In addition, the failure to have proper support made a high vibration to be transmitted to the weighbridge. This caused a drop in productivity and an increase in maintenance costs for corrective actions due to unscheduled shutdowns for cleaning the chute, maintenance and cleaning staff costs, replacement of conveyor components, etc.

*Enertec's conveyor belt suffered from impact damage and misalignment..*

A Martin® Impact Cradle was installed. The cradle was custom manufactured to meet specific customer requirements. The cradle had to be manufactured with stainless steel because of the acids that compose the electrolyte solution of the batteries they manage.

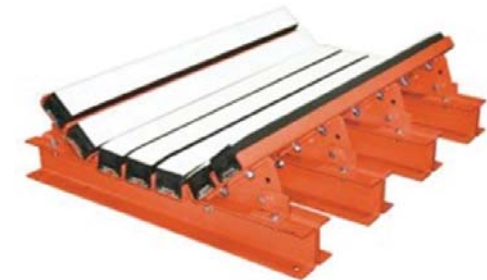
*The Martin® Impact Cradle stabilizes the belt line to eliminate belt sag and reduce fugitive material.*

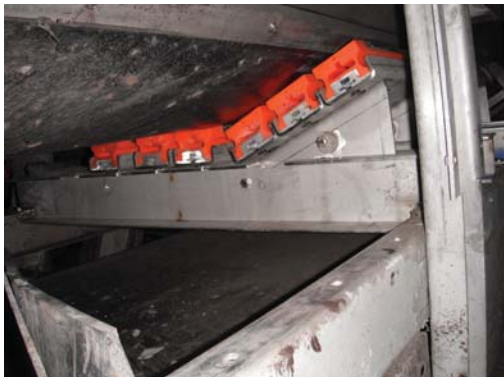
*Martin Engineering installed Martin® Impact Cradles on the Enertec conveyor belt used to recycle car batteries.*

All their problems of misalignment and impact damage were corrected after the impact cradle was installed. The customer is completely satisfied with the results and the work done by Martin's team. They lowered their costs and increased their productivity.
