PROBLEM SOLVED™ PAPER

SOLUTION: Martin® Arcoplate™
INDUSTRY: Iron Ore
LOCATION: Minas Gerais - Brazil

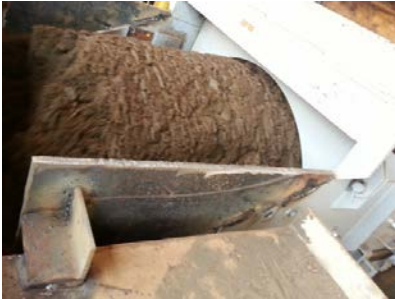
An iron ore mine in Brazil was experiencing premature deterioration on the wear plate of a main transfer chute, leading to perforation and spillage. During the 24/7 operating schedule, approximately 275 metric tons (250 short tons) of ore per hour would constantly pass over a 45 mm (1.7 inch) rubber wear plate. Every 60 days, operations would be interrupted while workers performed a potentially dangerous chute entry to cut out the material and replace it. Labor for cleanup of spillage, unscheduled downtime and expensive replacement equipment made the situation unsustainable.

Technicians from Martin Engineering Brazil installed an Arcoplate™ protective liner. The bi-metallic design layers a dense chromium carbide-rich metal alloy faceplate on top of a rigid steel back plate. The construction and smooth surface is engineered to withstand gouging, erosion, temperature extremes and material buildup. The 2-layer construction is tailored to the thickness, composition, shape and polish specifications of the application. Designed to increase wear life and improve workplace safety, the Arcoplate is available in three types to suit the material abrasiveness, impact and temperature of the application.

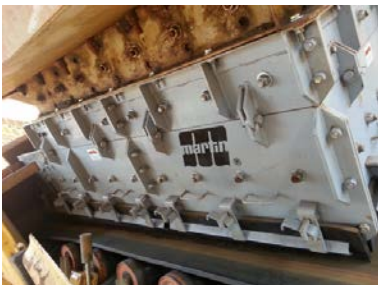
Following installation, managers have noticed a considerable decrease in wear, with more efficient material flow. There has been no unscheduled downtime for replacement, spillage has been reduced and workers no longer need to engage in hazardous chute entry for maintenance or replacement. “We are very satisfied with the results,” said company officials. “The chute’s performance has exceeded our expectations.” Due to the lower cost of operation and reduction in labor expense, managers are now in the process of purchasing a similar wear plate for another transfer chute within the company’s bulk handling system.
