# PROBLEM SOLVED™ PAPER

**SOLUTION:** Martin® High Speed Impact Cradles and Martin® ApronSeal™ Single Skirting

**INDUSTRY:** Mining

**LOCATION:** Coal Mine in Witbank, Mpumalanga, South Africa

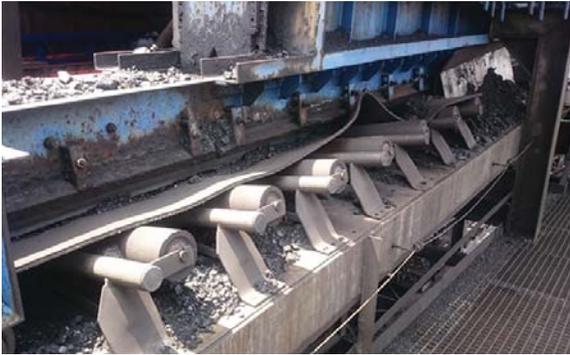
A coal mine in Eastern South Africa producing 3.1 million tonnes (3.4 mil. tons) of coal per year was experiencing heavy spillage and system damage along the length of a main conveyor due to inadequate loading zone equipment. Impact idlers allowed excessive belt sag, causing high volumes of spillage. Dust and fines fouled idlers, and rocks got lodged between the belt and the skirt, resulting in unscheduled downtime due to frequent equipment failures and chute liner replacements. Material built up and threatened to encapsulate the return run of the belt, so labor was diverted for cleanup, further raising operating costs.

*A coal mine in Eastern South Africa was experiencing heavy spillage and system damage due to inadequate loading zone.*

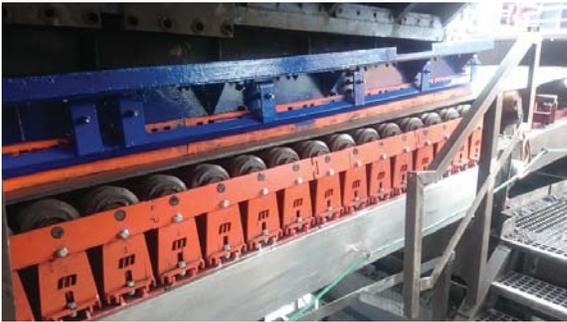
*Martin Technicians installed seven Martin® High Speed Impact Cradles along the length of the module 3 feeder unit.*

Martin South Africa was invited to offer a solution. Technicians recommended the installation of seven Martin® High Speed Impact Cradles along the length of the module 3 feeder unit. Using elastomer bar suspension to absorb shock from impact, the specially designed idlers exceed the operating limits of typical impact bar-type belt support cradles. The rolling components minimize friction on the belt and maximize the life of the belt support structure. Low-friction polyurethane Martin® ApronSeal™ Single Skirting was also installed to contain material and retain a tight seal on the running belt, further reducing spillage.

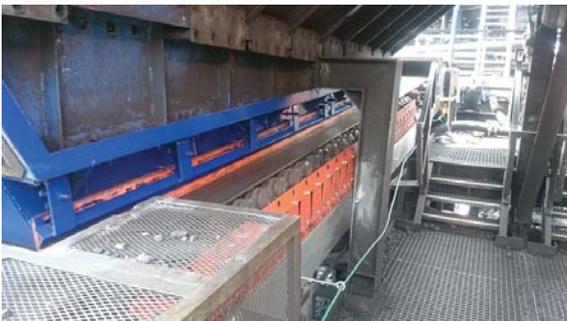
Six months after the installation, the volume of spillage has been reduced considerably, and the sealing system remains durable because no material is entrapped beneath the seal. The lack of fugitive material has mitigated wear and tear on components and reduced the amount of labor needed for cleanup, maintenance and replacement of broken equipment. "We're very happy with the end result," said a plant manager. "The project was so successful that we are going to convert the other 2 feeders in the plant (up to 14 more transfer points). This has definitely decreased the cost of operation."

*Six months after the installation, the volume of spillage has been reduced considerably.*
