# PROBLEM SOLVED™ PAPER

**SOLUTION:** EVO® Combination Cradle, EVO® Slider Cradles, ApronSeal™ Double Skirting, Walk the Belt™

**LOCATION:** Martin Marietta, Hunter Cement Plant, New Braunfels, Texas

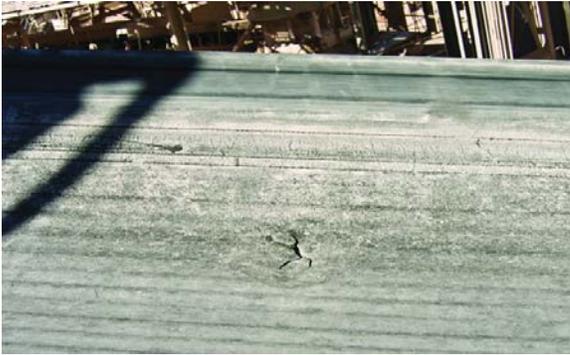
The Martin Marietta Hunter Cement Plant experienced equipment breakage, belt damage and spillage issues on the B-06 conveyor leading from the limestone storage dome to the facility. Approximately 400 tons (362.8 metric tons) per hour of limestone is loaded into a crusher that breaks down the rock to a size of 8-inch minus in diameter (203 mm), then deposits the material into a chute with a 20-foot (6-meter) drop onto a 42 inch (1066 mm) conveyor belt. The previous equipment was inadequate to handle the impact of limestone. Idlers cracked and cargo would not center sufficiently, causing excessive spillage around the transfer area and along the belt path, leading to long periods of downtime.

*A receiving belt can experience severe damage from material transfers if it's not supported properly.*

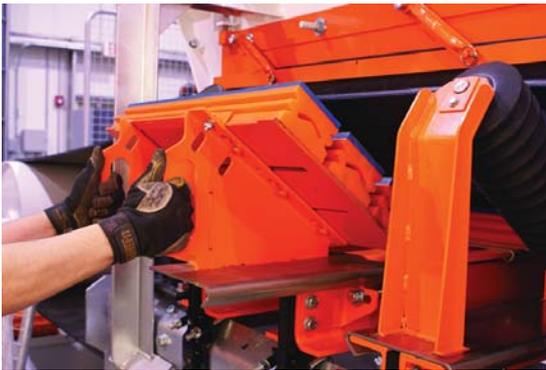
*The modular impact cradle absorbs the impact of the falling load, yet slides in and out for easy service.*

Martin technicians recommended an overhaul of the transfer system featuring three integrated solutions. Providing powerful, adjustable load support, the EVO® Combination Cradle is able to sustain an impact force of 12,000 lbs (5,443 k). The 34-foot-long (10.3 m) settling zone featured troughed EVO® Slider Cradles with low-friction, 62 durometer (shore D) UHMW polyethylene sidebars to center the cargo and reduce belt wear. The chute was raised slightly to accommodate the externally mounted ApronSeal™ Double Skirting, featuring primary and secondary sealing strips to keep a tight seal on the belt and prevent fugitive dust and fines. All of these technologies can be maintained without reach-in or chute entry.

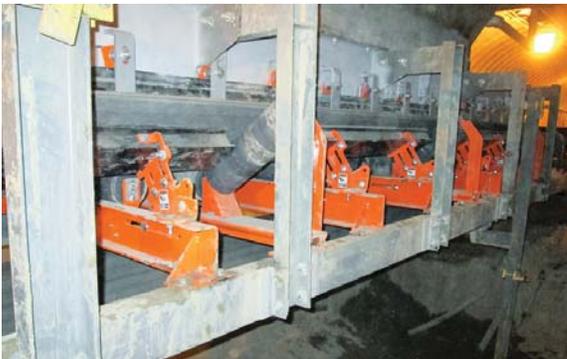
*The external skirting system contains fine particles and creates a more stable stilling zone.*

There has been no unscheduled downtime of B-06 since installation. Monthly Walk the Belt™ inspections conducted by Martin technicians have recorded healthy idlers and no apparent belt damage or need for replacement. Cleanup time of spillage has been drastically reduced to an as-needed basis, without the previously-required system shutdown. "We are extremely impressed with how the system is performing," said the company assigned Reliability Engineer. "The service and maintenance have been excellent, and we are already working with Martin on other projects to further improve operations."
