## **Conveyor Technology Guide**

## Conveyor Drop Points

### Preventing Damage and Spillage

That's the situation Martin Marietta found on the B-06 conveyor when the company merged with Texas Industries (TXI) — the largest cement producer in the state — and took over operations of the Hunter Cement facility in New Braunfels, Texas in 2014.

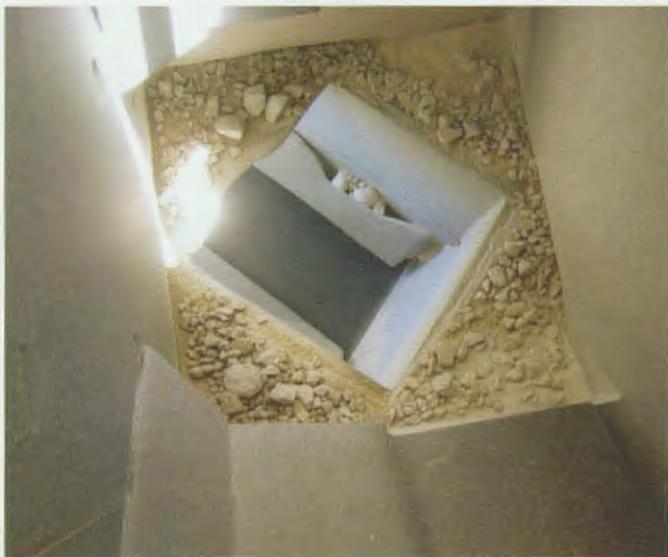
A rock box acts like a shelf, catching and distributing falling material onto the impact cradle.

After their analysis, the Martin Engineering team presented a detailed proposal offering a solution that involved several components working in concert to address the entire belt issue. "Our first recommendation was installing a rock box," Cole explained. "Set three feet above the belt, it would work like a shelf, catching

and distributing the limestone softly onto an impact cradle."

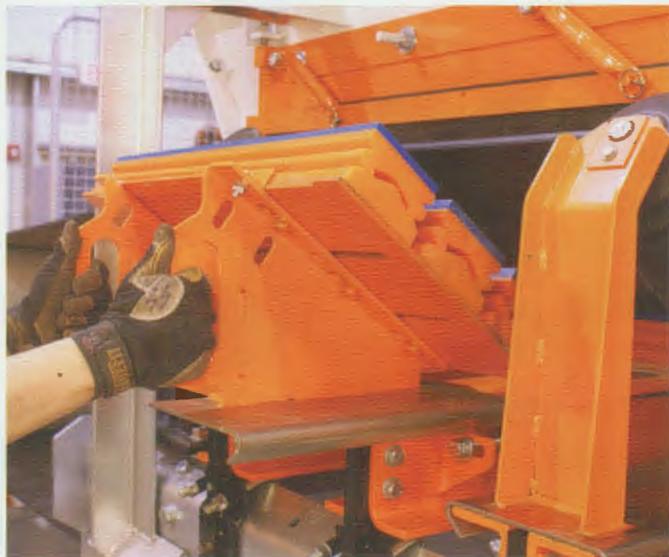
The modular impact cradle absorbs the impact of the falling load, yet slides in and out for easy service.

Located directly under the chute, the impact cradle is mounted on four rugged steel I-beam supports, able to sustain an impact force of 5443 Kg (12 000 lbs) by crushed material dropped from heights of up to 7.9 m (26 ft). The specially engineered impact bars are based on an aluminum T-slot design, which is surrounded by a layer of energy-absorbing 83A durometer urethane and coated with low-friction UHMW plastic to reduce friction and belt fraying. Wing supports adjust to a 5 percent fine-tuning angle, allowing the cradle to be precisely matched to the idler profile, assuring a tight belt seal and avoiding material shift on impact.

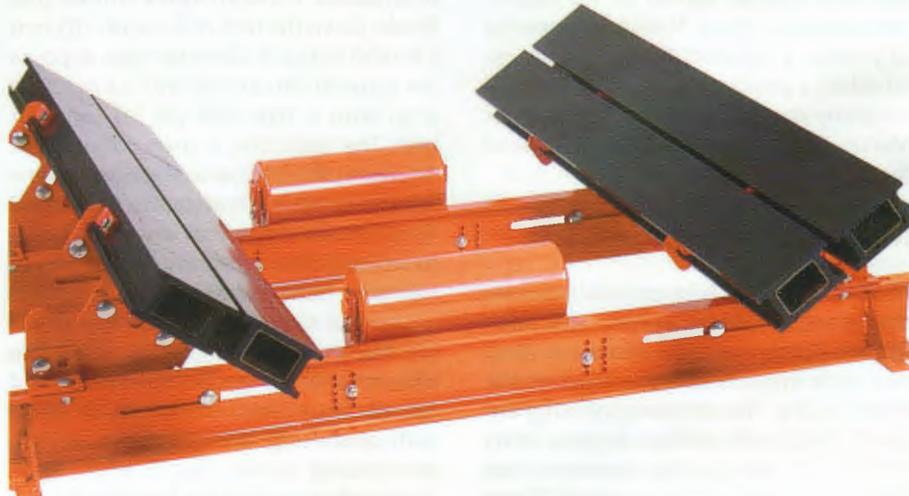
Slider cradles support the belt to prevent spillage from belt sag and eliminate material entrapment points.

Following the impact cradle within the 10.3 m long (34 ft) settling zone, the team recommended a series of adjustable slider cradles that support the belt to prevent spillage from belt edge sag and to eliminate entrapment points where material commonly got caught. To avoid belt fraying and reduce drive-power consumption, the loaded belt glides over low-friction, 62 durometer (shore D) UHMW polyethylene sidebars featuring the company's unique "box" design.

The sidebars are "double-life," which means they can be flipped over when one side is worn, providing a second wear surface. Using only hand tools, a single worker simply removes the release pin and pulls the unit away from the frame on its

track-mounted sub-assembly to adjust and replace components quickly.

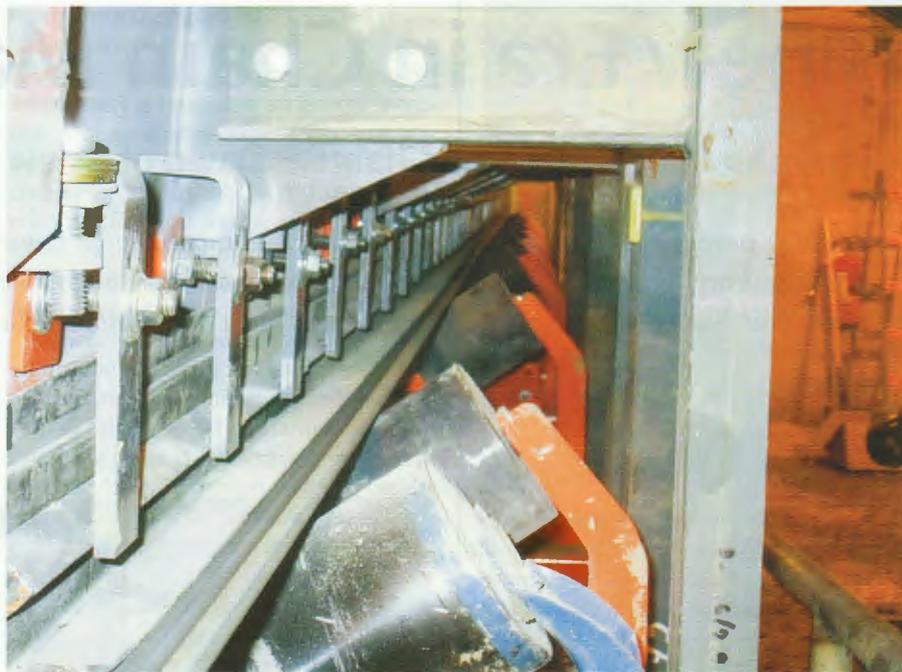
The external skirting system seals the chute to the belt.

Another key element of the assessment was an external skirting system along the chute box, sealing the chute to the belt. Specially designed to provide dual-seal efficiency with a one-piece 70 Shore D EPDM durometer rubber composite skirt and an attached strip, the skirting floats on the belt and self-adjusts to maintain an effective seal. Offering chemical resistance and low-abrasion index characteristics, once the skirt is worn on one side, it can be flipped for dual usage by disengaging the 182.9 cm (6 ft) long angle clamps. This can be done quickly using hand tools.

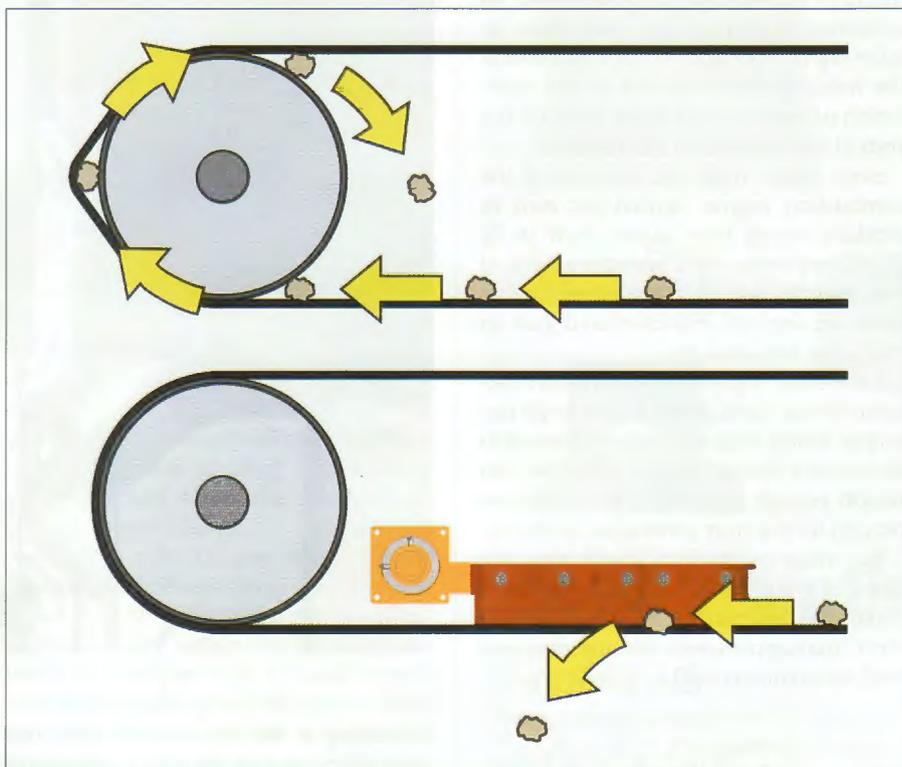
The V-Plow prevents material entrapment between the belt and tail pulley from becoming a repeating phenomenon.

"The wandering belt issue was also a huge concern, so we recommended a series of belt trackers with a parallel steering and training system every fifty feet," Cole added. "Another cause of misalignment was material getting caught between the belt and tail pulley, so we proposed a torsion V-plow as well."

Mounted on a dual steel bar attached to the mainframe a few feet from the tail pulley, the V-plow has a unique suspension system that allows the polyurethane blade to rise and fall with fluctuations in belt tension. Any material carried back on the top of the belt return is deflected to either side of the frame before it reaches the tail pulley.
