St Marys' conveyor clean-up

Carryback on the return side of conveyor belts impacts on plant operations and presents avoidable safety risks. St Marys Cement's Detroit cement plant decided to minimise, if not eliminate, carryback on its No 14 conveyor, to help improve plant operations.

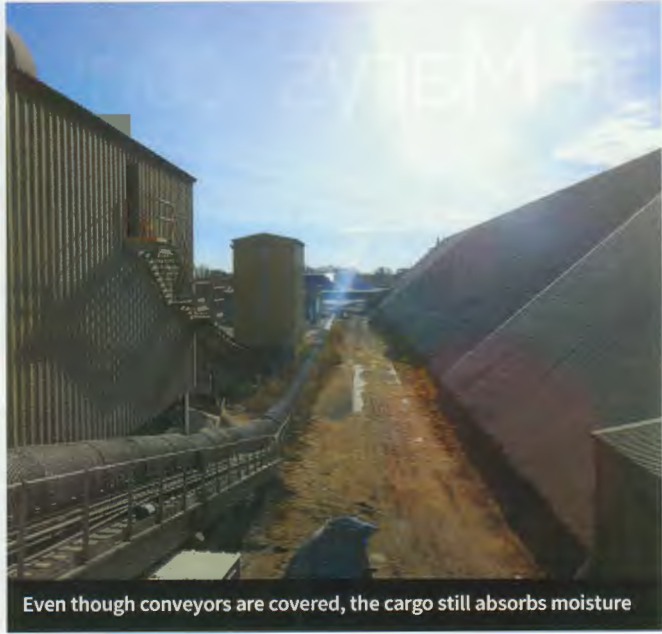
Even though conveyors are covered, the cargo still absorbs moisture

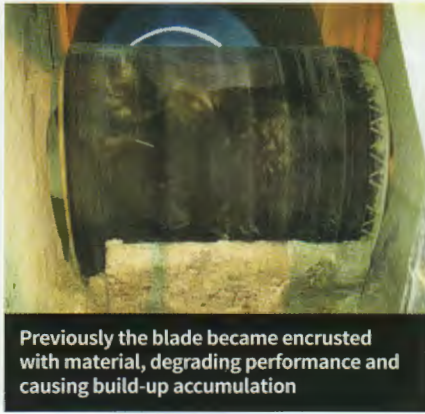
Previously the blade became encrusted with material, degrading performance and causing build-up accumulation

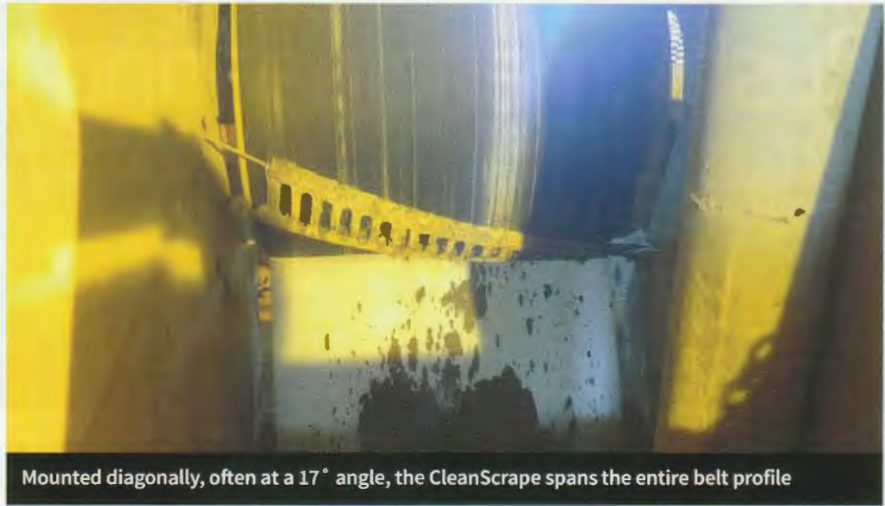
Mounted diagonally, often at a 17° angle, the CleanScape spans the entire belt profile

There are many traits that separate the CleanScape design from conventional urethane blade cleaners. Mounted using an upper and lower chain configuration attached to a Cleaner Tensioner Diverter, the surface spans the entire belt profile. The flexible cleaner is installed diagonally across the discharge pulley, forming a three-dimensional curve beneath the discharge area that conforms to the pulley's shape.

This design incorporates a matrix of tungsten carbide teeth and is tensioned lightly against the belt to prevent damage to the belt or splices. Despite extremely low contact pressure between belt and cleaner, it has been shown to remove as much as 95 per cent of potential carryback material. The low pressure allows the blade to pass over the No 14 conveyor's vulcanised splice without causing damage.
