# PROBLEM SOLVED™ PAPER

**SOLUTION:** Martin® N2 Position Indicator

**INDUSTRY:** Limestone Quarry

**LOCATION:** Singleton Birch, Melton Ross Quarry, Barnetby, UK

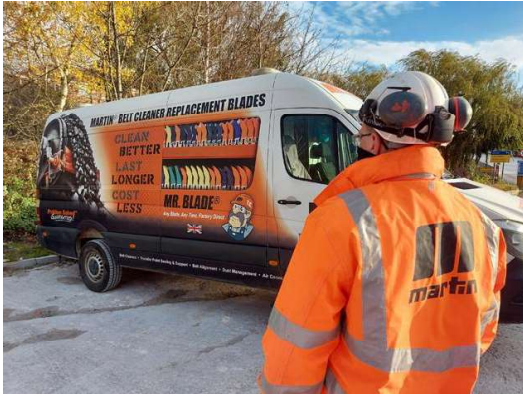
Site visits are conducted using the Mr. Blade truck, which is a self-contained blade servicing station.

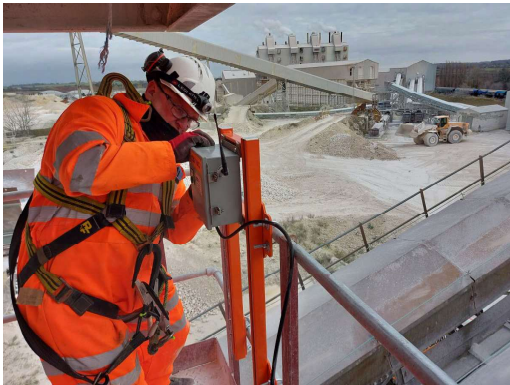
The N2 Gateway receives signals from installed PI units and sends data through the cloud to the app.

Martin representatives introduced the N2® Position Indicator (PI) technology to managers. One N2 Gateway and 43 PI units were installed. The equipment delivers remote monitoring of the belt cleaner blade status on mobile devices via the proprietary Martin Smart Device Manager App. Communicating through the gateway, the technology uses sensors to indicate remaining blade life, notifying technicians and operations personnel when re-tensioning or replacement is required. The PI maximizes the blade's usable surface area and reports with certainty when a blade is nearing the end of its useful life. It will also collect data and provide information on any belt cleaner utilizing a Martin blade.

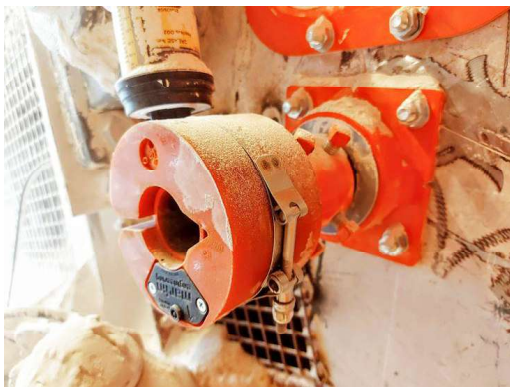
The N2 Position Indicator works with belt cleaners to maximize service and inspection efficiency.
