PROBLEM SOLVED™ PAPER

SOLUTION: Martin® Chevron Cleaner

LOCATION: Biomass Power Station, South-Africa

TITLE: Martin® Chevron Cleaner: Protecting Every "Step" Beneath the Conveyor

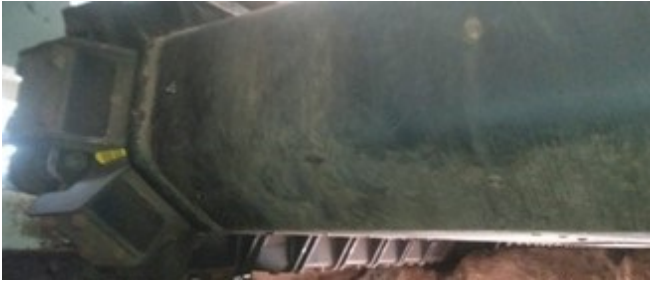
The wing pulley design means space is limited

An energy biomass power plant faced a persistent issue with wood fibre spillage accumulating under the Buffalo Feeder conveyor. This spillage was largely due to the 'wing pulley' design, which made it challenging to find a compatible cleaning solution that could fit within the confined space around the conveyor. The excessive build-up of fine wood fibre not only interfered with operations but also created a serious safety hazard, as the area directly beneath the conveyor serves as a walkway for employees. The spillage posed significant risks of slips, trips, and falls, threatening the safety of the workforce navigating this pathway daily.

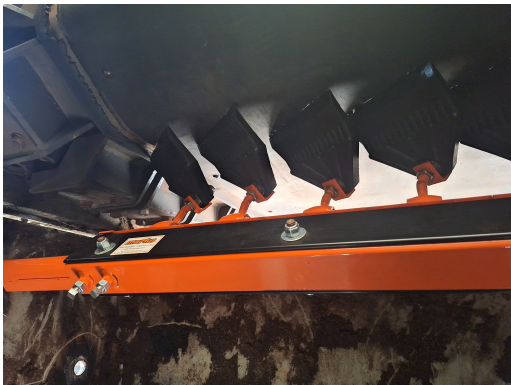
The Chevron Cleaner is ideal where space is limited

A Martin Engineering sales engineer conducted a site visit to assess the Buffalo Feeder conveyor and its spillage issues. Due to the conveyor's space constraints and design, the engineer recommended the Martin® Chevron Cleaner as the optimal solution. The Chevron Cleaner's design allows it to handle fine wood fiber material effectively, preventing spillage while working efficiently within the system's limitations. This solution significantly reduced wood fiber spillage, creating a safer environment for employees who use the area as a walkway.

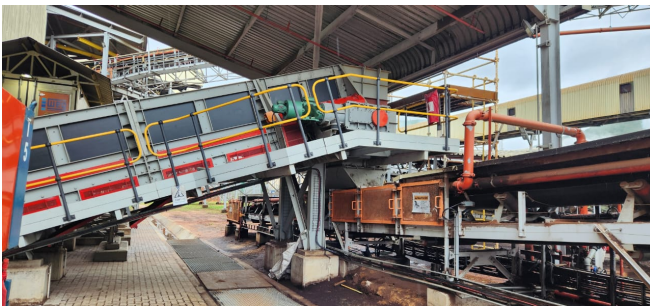
No more spillage on the walkway beneath the Buffalo Feeder!

The significant reduction in spillage has minimized the need for frequent manual clean-up, enhancing operational efficiency and reducing maintenance requirements. The reduced spillage also greatly improves safety, as it minimizes slip, trip, and fall hazards for employees who regularly traverse the area beneath the conveyor. The customer expressed satisfaction, stating, "Less spillage translates to less downtime needed for cleaning and has improved overall workflow and productivity. The support we received from the Sales Engineer, along with his recommendation of a specialized cleaner, truly came to our rescue."
