# PROBLEM SOLVED™ PAPER

**SOLUTION:** CleanScape® Primary Cleaners

**LOCATION:** JSW Steel Plant, Dolvi, Maharashtra

**TITLE:** CleanScape® proved higher cleaning efficiency & longer life than PU cleaners

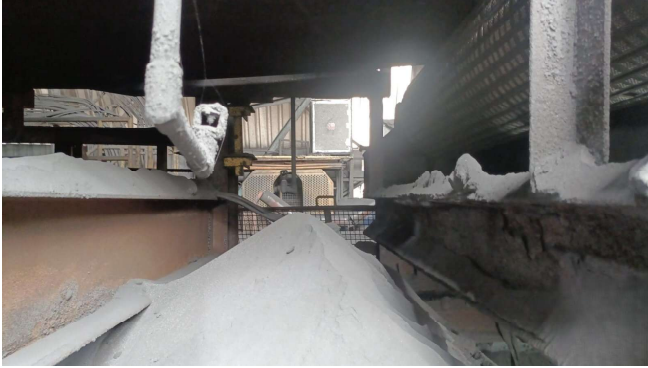
PU belt cleaners from other supplier were ineffective due to insufficient cleaning efficiency & rapid blade wear

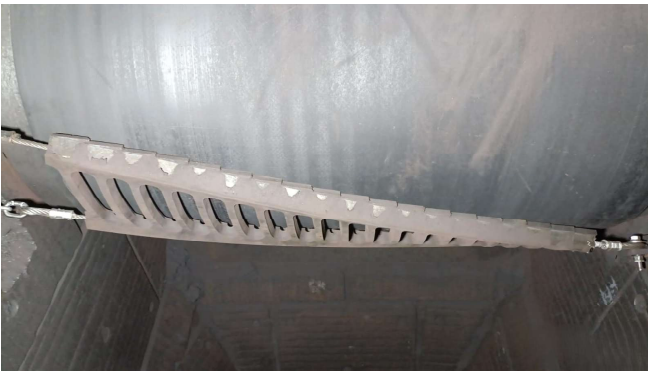
CleanScape® installed in minimal space, ensures optimal cleaning efficiency and longer service life

Martin Engineering experts team, together with a trusted partner, conducted a belt audit making note of the belt cleaner expectation and the abrasive nature of the cargo. The team recommended installing a Martin® CleanScape primary cleaners replacing the existing belt cleaners. Given the space constraints within the chute, the CleanScape® was an ideal solution due to its simple installation and minimal space requirements. The CleanScape® ensures low wear on both the belt and the cleaner, prolonging their service life. The tungsten carbide cleaning surface is completely corrosion-resistant, making it durable even in harsh environments. The cleaner requires minimal maintenance and comes with stainless steel installation kits for added durability.

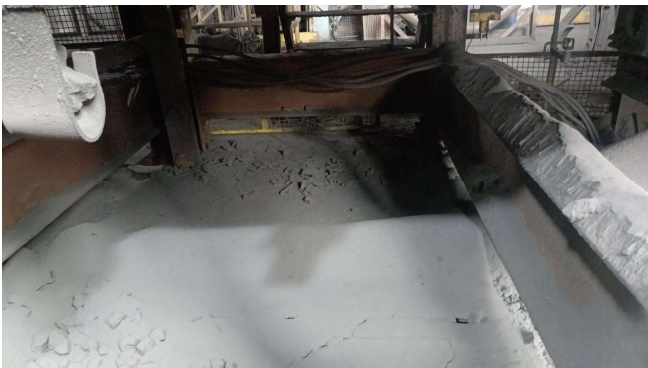
CleanScape® Primary Cleaner effectively reduced the material loss and associated operational challenges. +

After 12 months in operation, operators reported outstanding cleaning efficiency, with no adjustments or other maintenance required. The CleanScape® Primary Cleaner proved the optimal solution providing higher performance, longer life, reduced material loss and addressing the associated operational challenges. With less material accumulating under the belt, the manual clean-up time and associated manpower costs were significantly reduced. The customer is very happy with the performance, service and overall functioning of the proposed solutions and further orders have since been placed.
