PROBLEM SOLVED™ PAPER

SOLUTION: Martin® CleanScrape Belt Cleaner

INDUSTRY: Steel

LOCATION: NL Gent, Germany

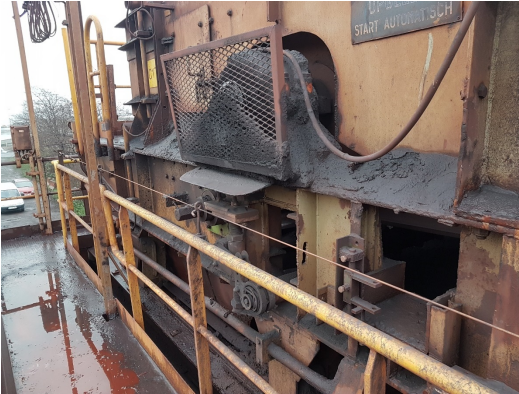
Fugitive material was causing lost cargo and forcing diversion of valuable manpower for cleanup.

Arcelor Mittal Gent, which is a valued dealer customer account for CleanScrape GmbH, handles 3 MTPA of iron ore as part of its steel production process. The material is carried by two conveyors. One of the systems (a 1400 mm wide belt running at 3.5 m/s) was experiencing carryback and fugitive material, despite having primary and secondary cleaners in place from another manufacturer. The problem resulted in the loss of valuable material and required manpower to be diverted from normal tasks to do clean-up. Both of these reduced overall process efficiency and negatively impacted productivity, ultimately reducing profitability.

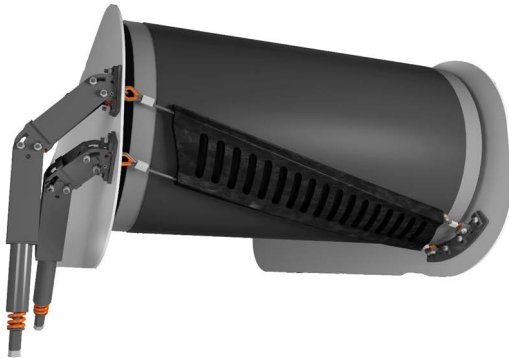
Unlike conventional scrapers, the CleanScrape cleaner is installed diagonally across the discharge pulley.

After reviewing the situation to determine the best possible solutions, making note of the high speed of the conveyor and the abrasive nature of the cargo, the CleanScrape GmbH team and the dealer's engineer recommended installing a Martin® CleanScrape HD primary cleaner to replace the existing 2-blade system. Unlike conventional belt cleaners that are mounted at a 90 degree angle to the belt, the CleanScrape cleaner is installed diagonally across the discharge pulley, forming a 3-dimensional curve beneath the discharge area that conforms to the pulley's shape. The unique design incorporates a matrix of tungsten carbide scrapers and is tensioned lightly against the belt to prevent damage to the belt or splices.

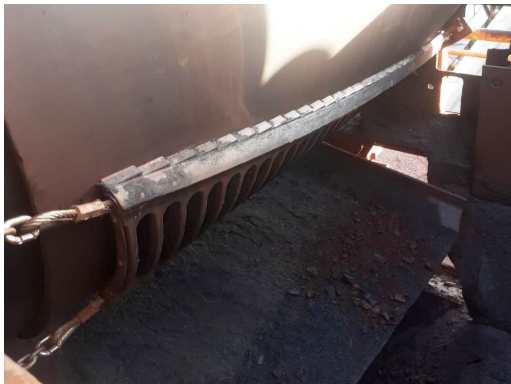
After 16 months, operators report outstanding cleaning efficiency, with no adjustments or maintenance required.

Despite extremely low contact pressure between belt and cleaner, the CleanScrape design has been shown to remove as much as 95% of potential carryback material. The innovative cleaner is ideally suited for both slow and fast conveyor belts, including those with mechanical splices. After 16 months in operation, operators report outstanding cleaning efficiency, with no adjustments or other maintenance required. They estimate that 80% of the wear life remains. "We are happy with the cleaner's performance and installation," observed Arcelor Mittal Support Manager Tim Vertriest.
