# PROBLEM SOLVED™ PAPER

**SOLUTION:** Martin® CleanScrape® Belt Cleaner

**INDUSTRY:** Port Terminal

**LOCATION:** TransNet Port Terminals, Richards Bay, KwaZulu-Natal, South Africa

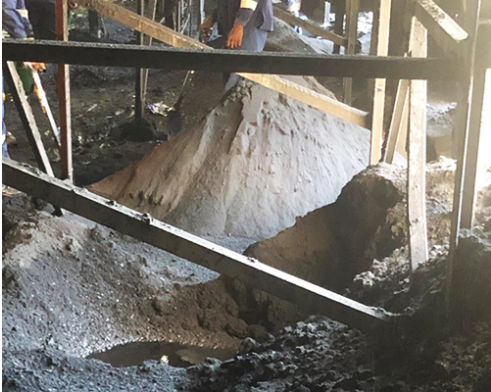
Piling waist high in some places, the spillage extended onto walkways and restricted safe access.

Invited to inspect the system and resolve the spillage issue, technicians from Martin Engineering South Africa performed a detailed Walk the Belt™ inspection to determine the best course of action. Due to the varying nature of the material, technicians replaced the existing cleaner with a CleanScrape Primary Cleaner. Installed diagonally across the discharge pulley to form a three-dimensional curve, the design uses a matrix of tungsten carbide scrapers to dislodge material. The cleaner is tensioned once upon installation, requiring no further adjustment. With 4x the equipment life of other cleaners, the CleanScrape reduces carryback and delivers superior performance, reducing the cost of operation.

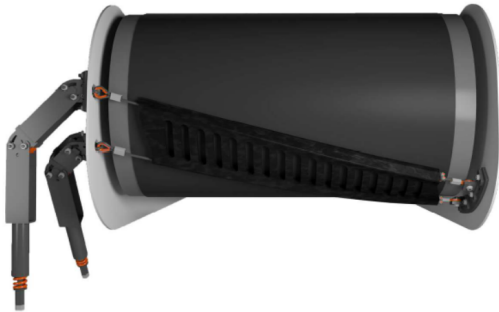
Low space requirements at installation allows the CleanScrape to fit into tight spaces.

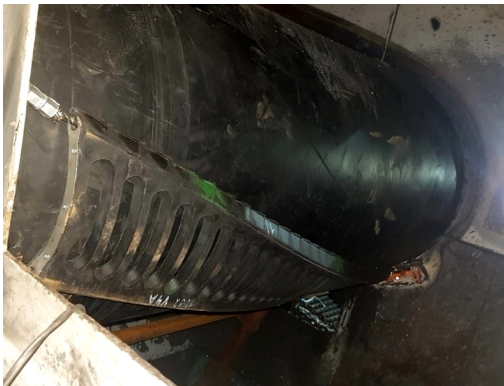
The unique design improves cleaning across the entire belt profile for more efficient discharge.
