PROBLEM SOLVED™ PAPER

SOLUTION: Martin® Impact Cradle MD

INDUSTRY: Steel

LOCATION: Tata Steel Ltd.; Kalinganagar, Orissa, India

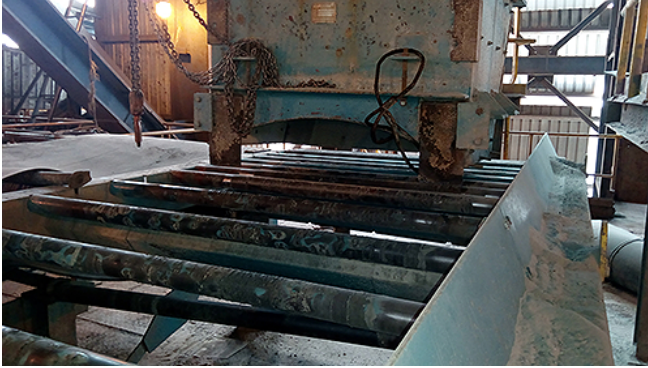
The high impact bent rollers and damaged bearings, increasing downtime and maintenance costs.
