PROBLEM SOLVED™ PAPER

SOLUTION: Martin® QC1™ Metal Tipped Cleaner

INDUSTRY: Cement

LOCATION: Podilsky Cement, Khmelnytsky, Ukraine

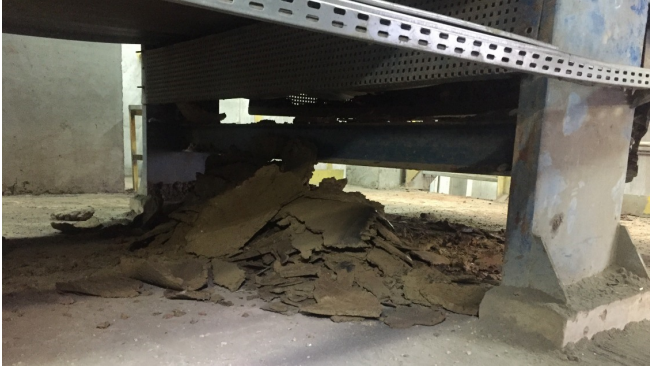
The curve of the head pulley caused the carryback to crack and drop below the belt in sheets.

Operators at Podilsky Cement, a CRH facility and one of the largest cement plants in Ukraine, noticed significant carryback dropping under one of the main raw material conveyors. Tacky clay and heavy pressure caused the belt to form an 8 mm (.31 in) layer of material that would cling to the belt and shed in sheets under the system. Along the entire length of the conveyor, spillage would pile up, and dust and fines would migrate to rolling components and fouling bearings, eventually causing them to seize. Cleaning and unscheduled downtime for repairs increased the cost of operation. Managers tried several brands of belt cleaners, but none were successful, so they contacted Martin Engineering for an affordable and lasting solution.

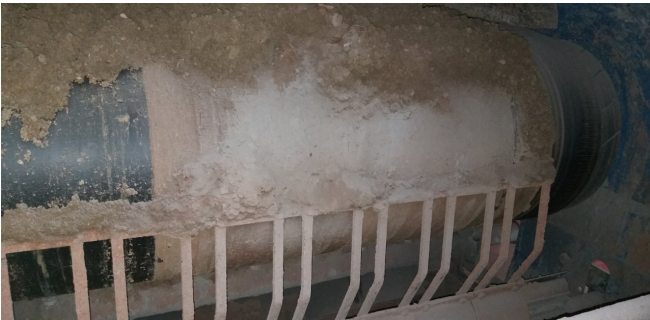
Previous cleaners allowed carryback to remain due to inadequate tensioning and uneven contact.

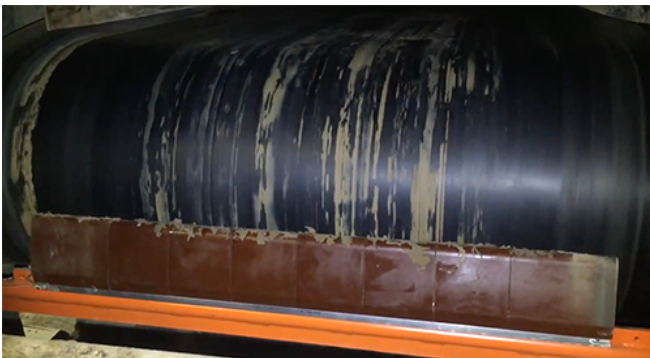
The Martin® QC1™ Metal Tipped Cleaner removes the difficult carryback from the belt.

Martin Engineering Ukraine technicians visited the site and examined the system by performing Martin's stringent Walk The Belt™ procedure. They determined that the Martin® QC1™ Metal Tipped Cleaner would achieve a higher level of productivity and reduce costs associated with carryback and equipment replacement. Using Constant Angle Radial Pressure (CARP) technology with a Martin® Twist™ Tensioner, the blade maintains consistent contact with the belt and constant belt cleaning pressure as it wears. The blade is set in a series of cartridges that fit together into one seamless unit but can be replaced in a modular manner if uneven wear occurs.

Upon replacement, the belt was put through four full rotations and the blade cleared the belt of stuck-on clay. After operation for an extended period, operators noted a drastic reduction in spillage under the belt and almost no fouling of rolling components from dust and fines on the return side. This reduced the amount of cleaning required, as well as unscheduled downtime for expensive equipment replacement, reducing the cost of operation significantly. "We are very happy with the outcome and are budgeting to add another cleaner to our feeder conveyor," said one manager close to the project.
