PROBLEM SOLVED™ PAPER

SOLUTION: Martin® Arcoplate

LOCATION: Cimento Apodi at São José do Mixira, Brazil

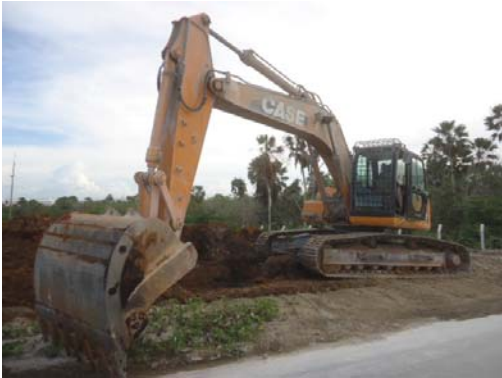
Cimento Apodi, a cement plant in São José do Mixira in Eastern Brazil, was experiencing wear damage to the underside of the bucket on its excavator. Scooping slag and clinker off of a cement floor covered with a layer of crystalline residue, the bucket would scrape against the coarse material, degrading the metal and reducing the structural integrity. As a result, the 24-hour operation experienced regular unscheduled downtime.

Cimento Apodi was experiencing wear damage to the underside of the bucket on its excavator.

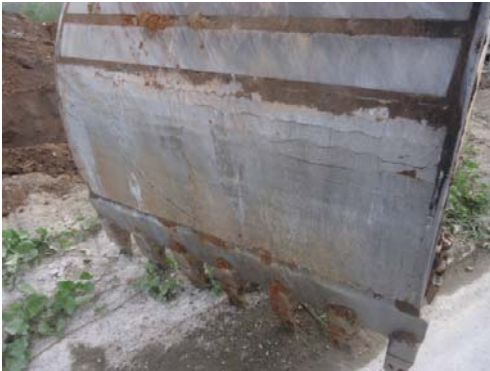
Martin® Arcoplate™ wear plate was installed across the face and around the curvature of the bucket.

A Martin® Arcoplate™ 1600 bi-metallic wear plate was installed across the face and around the curvature of the bucket, protecting the entire underside from premature wear during the device's full range of movement. The layered construction combines a 7mm steel base plate with a 6mm thick abrasion- and impact-resistant alloy top layer, featuring a hardness of 725Hv – 60Rc – 650BHN for outstanding wear resistance.

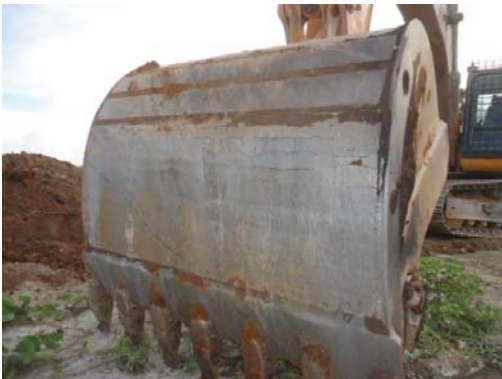
Martin® Arcoplate™ has kept the excavator bucket protected, with no maintenance or downtime due to wear.

After 4,325 hours of work, the Martin® Arcoplate™ has kept the excavator bucket protected, requiring no maintenance or downtime due to wear. Customer contacts report that they are “very satisfied” with the product and service, and have shown further interest in applying the Martin® Arcoplate™ to the sides of the bucket and other equipment applications.
