PROBLEM SOLVEDTM PAPER

SOLUTION: Martin® Conveyor Guards

INDUSTRY: Mining

LOCATION: Taconite Mine in the Upper Midwest US

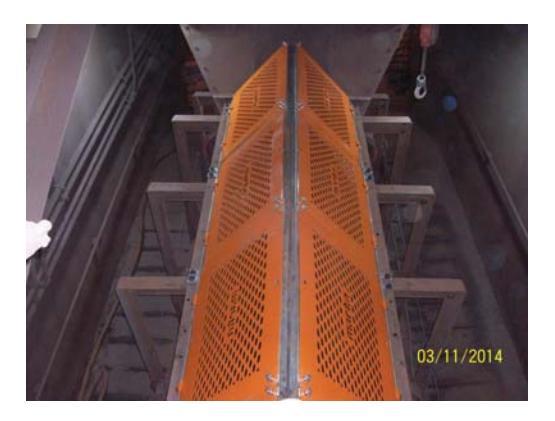
Martin® Conveyor Guards prevent material from spilling off the belt.

The mine decided to equip their conveyor with Martin® Conveyor Guards. Simple to install, the conveyor guards can be removed and reinstalled quickly by using wedge clamps. Locking tags are included for extra security. Designed to be universal, guards are available in several sizes and can be used in a variety of combinations to fit almost any application. Custom guarding design is also available. This versatility made it easy for the mine to use conveyor guards to prevent the ore from falling off the belt, solving their safety and efficiency problems. The rugged modular design is self supporting and installs on supplied angle iron structure, not the conveyor structure.

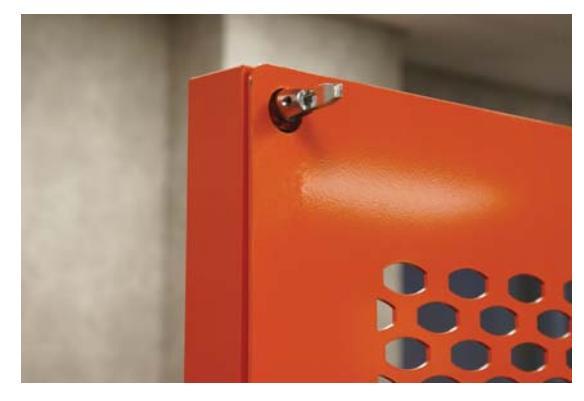
Wedge clamps allow the conveyor guards to be removed and reinstalled quickly without the use of tools.
