## PROBLEM SOLVED™ D5D9F

SOLUTION: Martin® Air Cannons

**INDUSTRY:** Cement

LOCATION: Ash Grove Cement Company Louisville, Nebraska

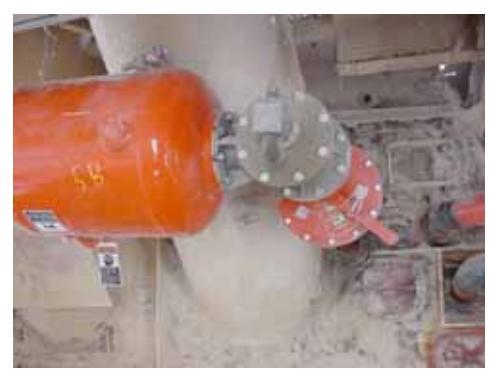
Martin® Air Cannons with Martin® Thermo Safety Shield

The installation included the Martin® Thermo Safety Shield to protect maintenance personnel when they inspect or service the air cannon system. A crew from MartinPLUS® Services performed the project.

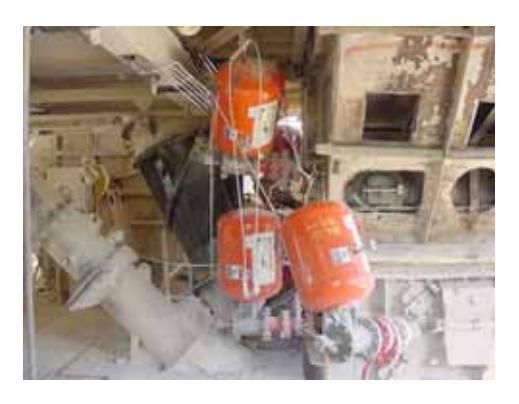
Martin® Air Cannons were installed on the pre-heater tower.

To control the material buildups, the plant ordered installation on the kiln riser duct of a battery of twenty-five Martin® Air Cannons supplied by Martin Engineering. This installation placed the air cannons below the riser orifice, where the duct is reduced in size to increase air velocity.

The air cannon discharge sequence moves upward in a spiral, with one air cannon firing and the next firing twenty seconds later. The entire system discharges over an eight-minute cycle, and then repeats. Control room operators can alter the firing schedule to adjust for kiln pressures readings. The plant has varied cycle length from eight minutes to as much as forty-five minutes, depending on operating conditions.
