## **PROBLEM SOLVED™ PAPER**

SOLUTION: Martin® Typhoon Air Cannon, SMART™ Series Jet Nozzle

**INDUSTRY:** Cement

LOCATION: JK Lakshmi - Sirohi, Rajasthan, India

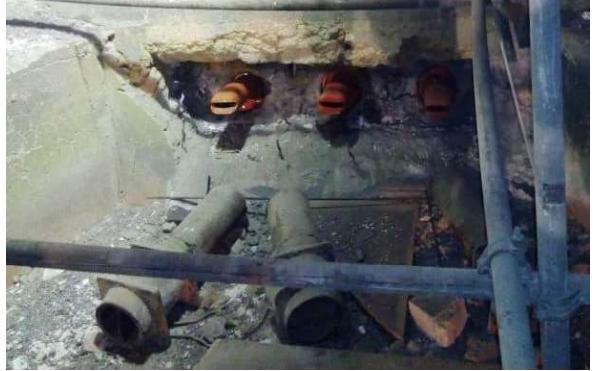
The old nozzles below had to be cut out, while the new orange ones simply slide out from the Y assembly.

Leading up to a scheduled shutdown, managers invited the Martin Engineering India team to inspect the area and provide a solution. To offer more powerful performance with less draw on the compressed air system, technicians installed five 70L (19 gallon) Martin® Typhoon Air Cannons mounted on Y pipe assemblies with SMART<sup>™</sup> Series Jet Nozzles. The Typhoon features a smaller tank delivering improved per-shot pressure and a back facing valve for easy maintenance without tank removal. The Y pipe assembly offers permanent mounting for easy tank and nozzle replacement, with no shutdown required. The SMART Series Jet Nozzles are made to withstand high heat environments with a slotted head design for greater spread and no back-flow.

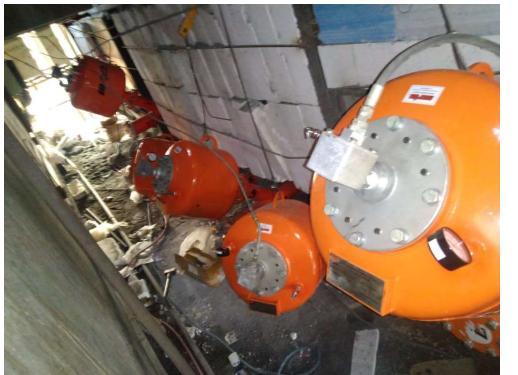
The cannon configuration directs pressurized air toward critical areas to minimize accumulation.
