PROBLEM SOLVEDTM PAPER

SOLUTION: Martin® ApronSeal[™] Skirting, Martin® Slider Cradle, Martin® Impact Cradle, Martin® Dust Bag

INDUSTRY: Mining - Coal

LOCATION: Yanzhou Dongtan Coal Plant in Eastern China

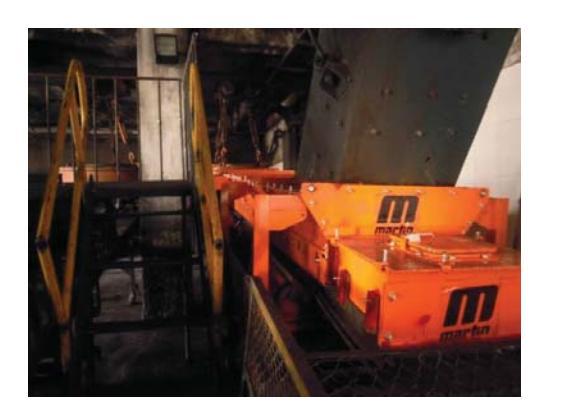
The Yanzhou Dongtan coal plant had spillage and dust issues, causing repeated downtime and increased labor cost.

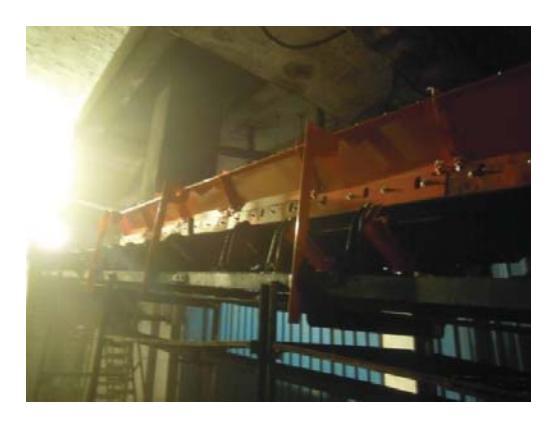
MartinPLUS® Technicians installed transfer point solutions to address the problems.

After an on-site inspection, MartinPLUS® Technicians installed transfer point solutions addressing both conveyors' unique issues. On #111, a 16.5-foot (5 m) transfer chute distributed material into a 40-foot (12 m) long sealed stilling zone equipped with a full-length Martin® ApronSeal[™] Skirting and a series of Martin® Slider Cradles. The 85foot (26 m) chute on belt #185 required a Martin® Impact Cradle, Martin® ApronSeal Skirting[™] and Martin® Slider Cradle support down the entire length. Both chutes featured a Martin® Dust Bag.
