IMPROVED ACCESS REDUCES CONVEYOR MAINTENANCE TIME

Inspection doors and track-mounted components facilitate maintenance for extended equipment life.

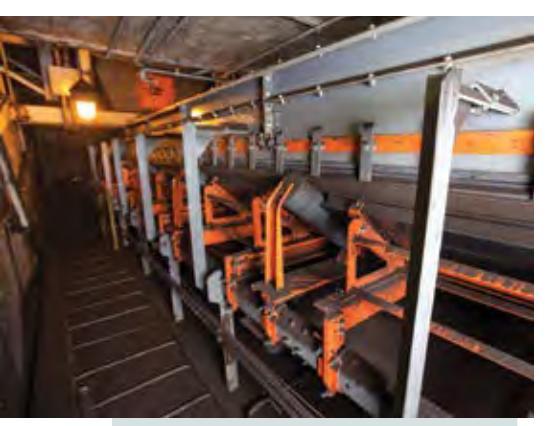
Track-mounted idlers allow easy access for quickly swapping out seized rollers.

Along the cargo path in the settling zone and beyond, retractable idlers support the belt and maintain the trough angle. Exposed to the punishing environment, gritty dust and extreme weather, rollers can seize over time. Often set closely together in the loading zone to avoid belt sag, slideout/slide-in roller frames permit workers to perform idler service outside of the belt plane without the need to raise the belt or remove adjacent idlers.
