ISSUE NO. 257 MAY 2022

Keeping fugitive material in its place

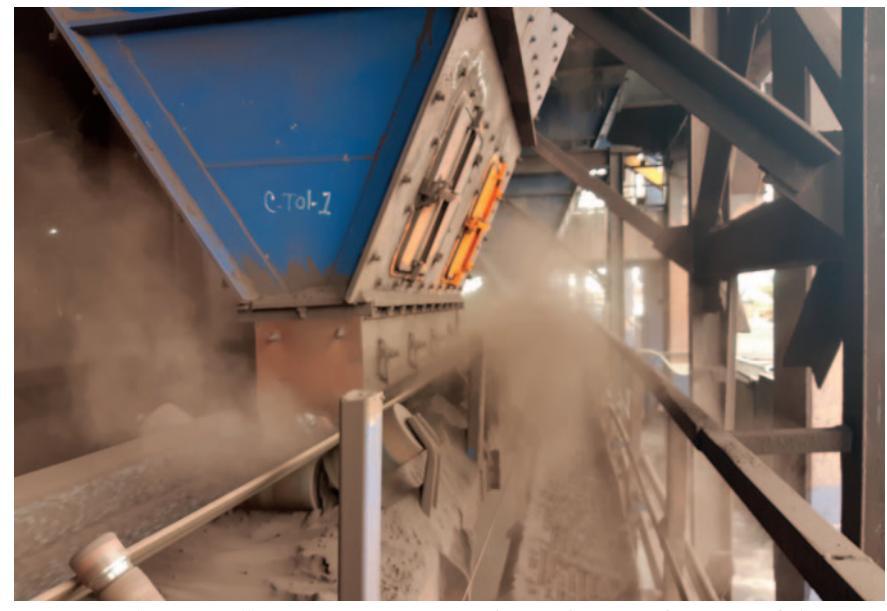
Dust accumulation on rolling components can cause abrasive damage and premature failure.

If left uncontained, fugitive material in the form of dust and fine particle spillage will increase labor costs for cleanup, foul equipment, potentially encapsulate the belt and pose a serious safety hazard. A dirty and dusty environment also discourages workers from doing regular maintenance on the problem area and negatively affects morale.

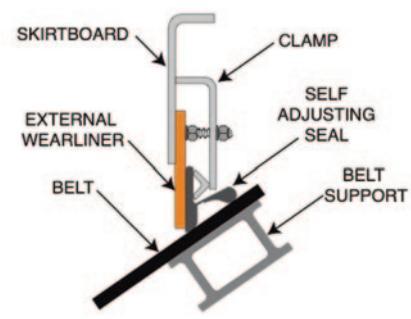
External wear liner and dual self-adjusting seal with belt support. © 2022 Martin Engineering Company

Finally, skirtboard sealing systems were installed on the sides of the loading zones to contain dust, eliminate spillage and reduce cleanup. The dual-sealing system incorporates a primary seal clamped on the steel skirtboard to keep lumps on the belt and a secondary or 'outrigger' strip to capture any fines or dust particles that pass beneath the primary seal. The secondary seal lies gently on the belt and self-adjusts to maintain consistent stripto-belt pressure, despite high-speed material movement and fluctuations in the belt's line of travel. The unique design incorporates two wear surfaces on a single elastomer sealing strip, installed along the bottom of the skirtboard. When the bottom side of the strip against the belt is worn, the sealing strip is simply flipped over to deliver a second service life.

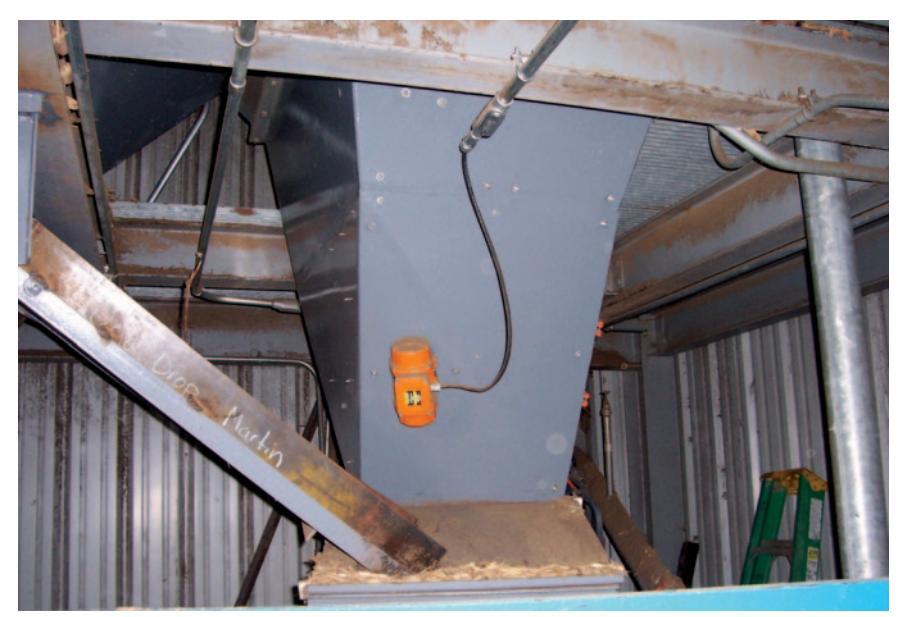
A field-fabricated drop chute fitted with a vibrator to improve material flow to the new transfer point.

The installation team also placed electric rotary vibrators in key locations on drop chutes to reduce the potential for plugging. To further ensure control of fugitive material, settling zones were created at the transfer points to slow the air speed, with dust curtains to contain airborne particles.

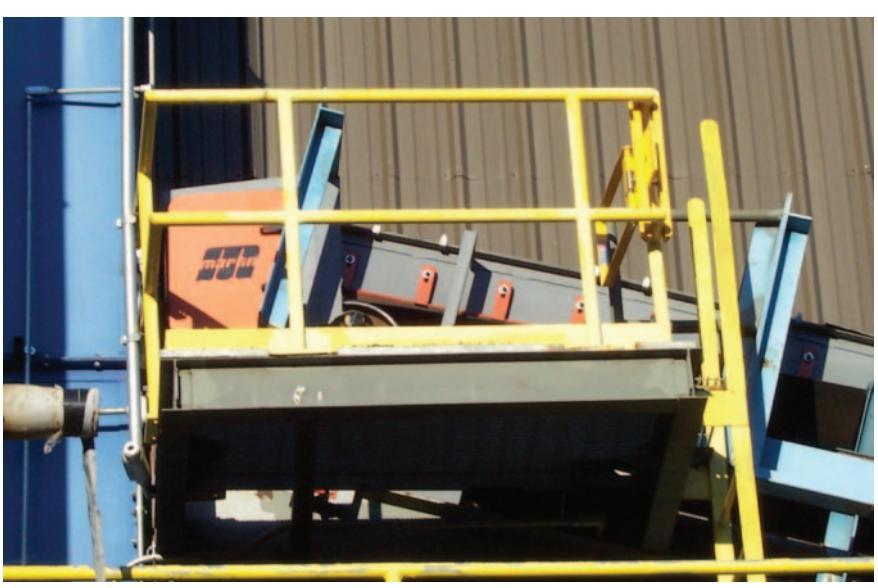
A new head chute and brush cleaner reduced dust by an estimated 95% at the bucket elevator.

The primary units on each belt are brush-type cleaners, a unique electricpowered design that provides an effective, cost-efficient solution for residual beltborne material. The secondary units are versatile 'deflected blade' designs that feature a gentle pressure to prolong service life and prevent belt damage.

"We installed electric brush cleaners on each conveyor, because they're very effective on the type of cleated belts used at this facility," observed the Martin Engineering Territory Manager. "The rotating brush delivers good cleaning performance in difficult applications, including belts with ribs, grooves or chevrons, and belts carrying sticky materials or stringy fibres."
