## **PROBLEM SOLVED™ PAPER**

SOLUTION: EVO® Transfer Point Load Zone

**INDUSTRY:** Silver Mining

LOCATION: Coeur Mining, Inc. / Pershing County, Nevada (USA)

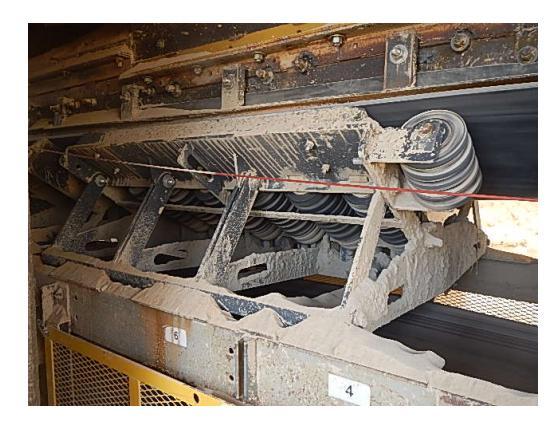
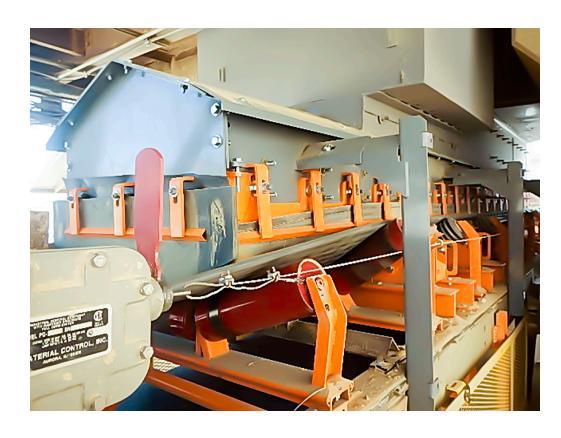
One of the largest silver producers in North America was experiencing excessive dust and spillage on the conveyor leading from the crusher to the surge pile, which lowered air quality, required 5-10 man-hours per day to clean, and caused unscheduled downtime from premature equipment failure. "There's a long fall going to the secondary crusher, and that creates a huge disturbance in the material flow," explained a plant supervisor. "We were seeing a lot of dust and spillage in that area, which meant putting personnel in close proximity to the moving conveyor for cleanup." The operations staff also noticed belt damage occurring as a result of fugitive material.

Over a 7-day period, 5 Martin® EVO Combination Cradles were installed to absorb the impact of the falling load, along with 5 EVO Slider Cradles to stabilize the belt line. Forty feet (12.2 m) of modular chute wall replaced the old structure, with a tail box and integrated dust curtains. At the bottom of the wear liner, installers mounted 84 linear feet (25.6 m) of Martin ApronSeal<sup>™</sup> Double Skirting. To maintain a consistent belt path, technicians then installed a Martin Belt Tracking System. A dual belt cleaner system was mounted on the face of the head pulley, with a Martin Torsion V-Plow to protect the tail pulley. Completing the upgrade was an integrated air cleaner, incorporated directly into the dust generation point.
