PROBLEM SOLVED™ PAPER

SOLUTION: Martin QB1[™] HD, QC1 HD and DT2S[™] Belt CleanersINDUSTRY: Coal-Fired Power & Steel

LOCATION: Bhushan Power & Steel Plant, Thelkoloi, Sambalpur, Odisha (India)

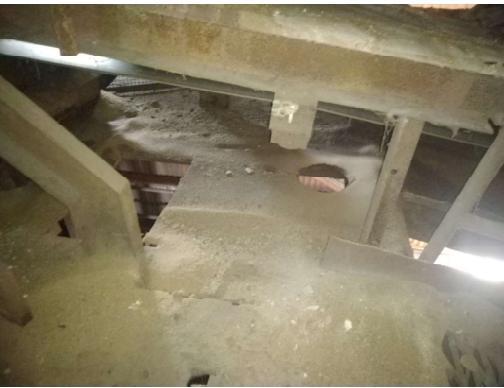
Ineffective belt cleaning led to extensive carryback, which accumulated all along the return run.

The Bhushan Power & Steel Plant in Thelkoloi, Sambalpur, Odisha (India) was experiencing extensive belt cleaning issues on conveyors CW2C1 & J32C1 (CW-2), which transport approx. 2.5 million tons of coal per year. Inefficient cleaning resulted in significant carryback and material loss along the return path, while also contributing to premature component wear, increased clean-up time and higher manpower costs. Further, the accumulation created potential safety hazards from clean-up efforts near the moving conveyor, as well as trips and falls. Management wanted to find a solution that controlled carryback and the resulting maintenance time, returning lost material to the cargo stream and improving overall efficiency.

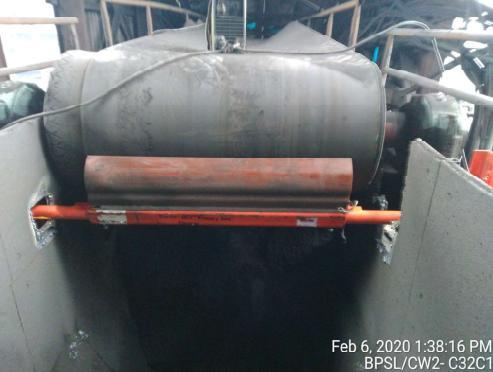
To replace the QB1 blade, one worker simply pulls the locking pin, unclamps the bracket and slides it out.

After conducting a thorough inspection of both conveyors, the Martin Engineering India team installed a QB1[™] HD Primary Cleaner on one conveyor and, QC1 HD Primary and DT2S Secondary cleaner on another. Manufactured with the company's unique "CARP" (Constant Angle Radial Pressure) technology to maintain the most efficient cleaning angle through out its service life, the Martin® primary belt Cleaner features a no-tool replacement process that can be performed safely by one person in less than five minutes. Installed directly after the primary cleaner is the Martin DT2S secondary belt scraper featuring rugged individually-cushioned tungsten carbide blades installed on a track that slides into position on a rigid steel mandrel.

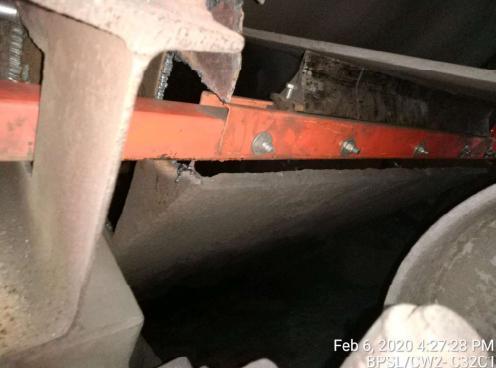
The DT2S features tungsten-tipped rubber blades to withstand medium-duty applications.
