# PROBLEM SOLVED™ PAPER

**SOLUTION:** Martin® QC1™ Cleaners HD and Martin® secondary belt cleaners

**INDUSTRY:** Cement

**LOCATION:** Conch Cement, Suzhou China

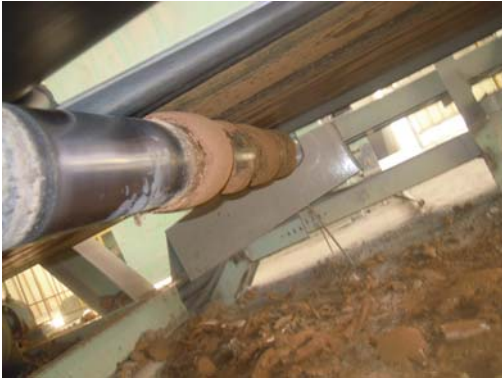
Conch Cement (Suzhou) mining factory uses their #1003 and #1009 belt conveyors to transfer limestone and clay. The belt width is 1.8m and 1.2m and runs at a belt speed of 2.5 m/s. They were using a competitor's belt cleaners previously but they were not satisfied with the results. The factory workers had to clean up the excessive spillage daily on the return belt. The labor intensity got very high when the spillage mixed with water on rainy days. The factory was replacing the blades frequently at a great expense as well as, paying workers to clean up the spillage during unplanned downtime, creating additional exiting safety hazards.

*Conch Cement had excessive spillage on the return belt on the conveyors transferring limestone and clay.*

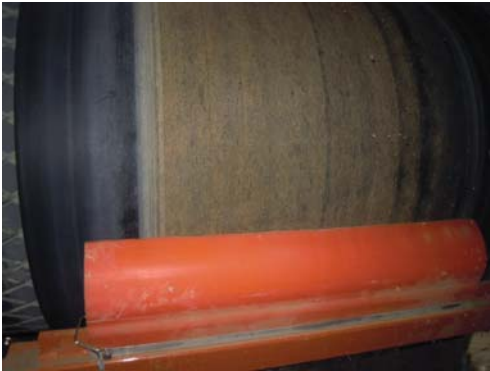
*The Martin® QC1™ Cleaner HD is suited for heavy-duty applications.*

After conducting an on-site inspection, Martin Engineering installed Martin® QC1™ Cleaners HD and Martin® secondary belt cleaners. Martin® QC1™ Cleaners HD can clean up to 90% of the carryback on the belt return. Martin's patented CARP blade design maintains consistent cleaning through all stages of blade wear, which maximizing the belt life. Martin also organizes on-site training for the plant workers. While the Martin technicians provide regular testing and adjustments after installation and regular maintenance.

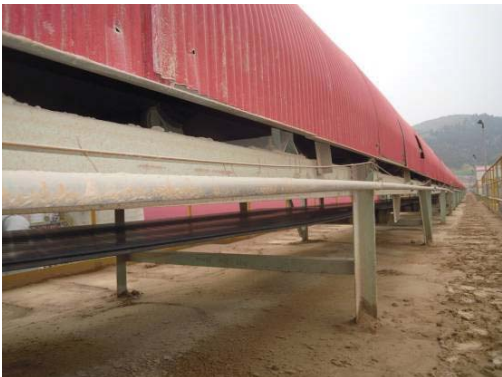
*The Martin® belt cleaners have greatly improved the efficiency of the conveyors.*

The customer was very happy with the Martin® belt cleaners. The workers only need to clean up a small amount of buildup once every seven days, which greatly improved the labor efficiency. Less spillage leads to less health hazards and environmental concerns. Martin belt cleaners protect the belt and reduce unscheduled downtime and emergency outages. Belt cleaners from Martin make conveyor systems cleaner, safer and more productive.
