# PROBLEM SOLVED™ PAPER

**SOLUTION:** MartinPLUS® Installation Services, Martin® Electric Vibrators

**LOCATION:** F.B Culley Generating Station (Vectren Corp./SIGECO)  
Newburgh, Indiana

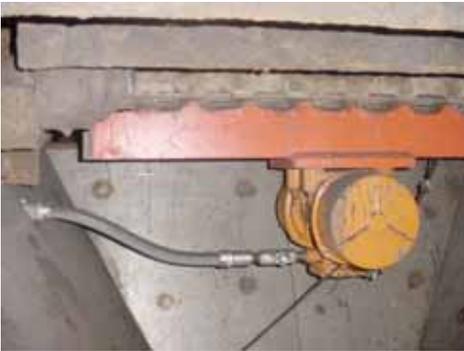
*To improve coal feeding, a new vibrator  
and channel mount were installed on a  
vibrating feeder pan at F. B. Culley Station.*

To improve the situation, MartinPLUS® Services installed a Martin® Electric Vibrator on the bottom of the feeder pan. The crew also removed the existing UHMW lining and replaced the cables that suspend the vibrating pan.

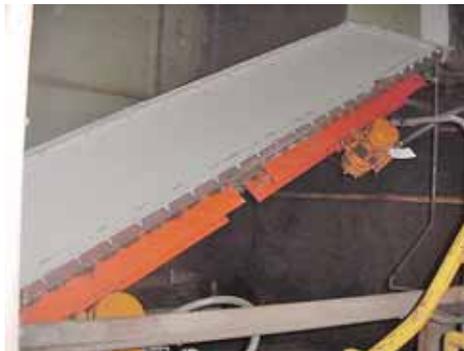
*The installation included new chute linings with  
stainless and two electric vibrators on channel  
mounts installed by MartinPLUS® Installation Services.*

The crew also rebuilt a 24 by 24 inch (600 by 600 mm) 18-foot (5.5 m) long “downcomer” coal chute, lining its bottom with 304 stainless steel. They installed two Martin® Electric Vibrators on a channel mount on the outside of the chute to maintain material flow.
