# PROBLEM SOLVED™ PAPER

**SOLUTION:** Martin® Hurricane Air Cannons

**INDUSTRY:** Mining - Lime

**LOCATION:** Lhoist UK (Steetley Dolomite), Whitwell, UK

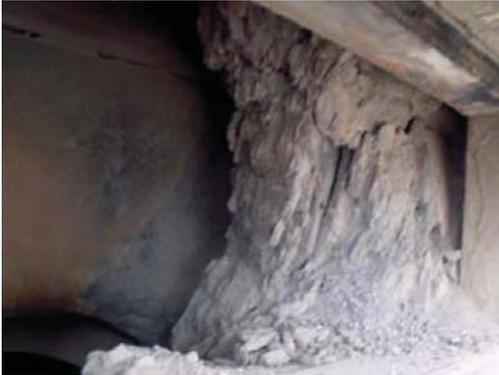
The existing lime kiln at Whitwell, had been upgraded in 2014 with the addition of a pre-heater element to allow the plant to burn waste derived fuels to save on energy costs. The introduction of the pre-heater section with its push rod type design started to give build up issues with the limestone chippings around the main feed section and also in the lower kiln feed chute. Production was now critical with many kiln stops for manual cleaning and rodding. In addition Cardox was now necessary due to the weight of the build up present.

*The pre-heater at Lhoist Whitwell started to develop build up issues with limestone chippings around the main feed section.*

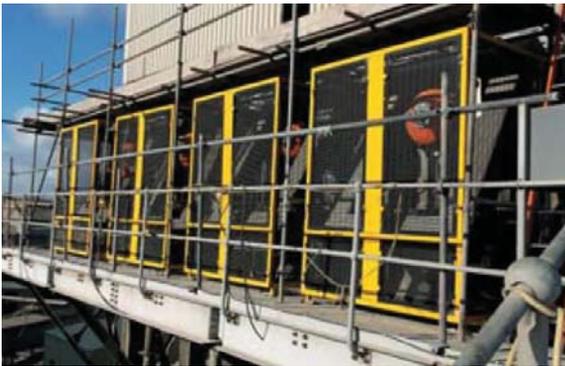
*The area was a very tight design, so the Martin® Hurricane Air Cannons were chosen due to the compact design.*

Lhoist asked Martin Engineering to look at solutions involving air cannons located around the bull nose push rod area of the material feed section and also the area of the kiln feed chute. The area was of very tight design, so the Martin® Hurricane Air Cannons were chosen due to the compact design. In addition, the area was lined with brick refractory, so cast nozzles of fish tail design would not work well and the plant wanted to install nozzles quickly so Martin suggested the Martin® Hi-Velocity Nozzles for these areas.

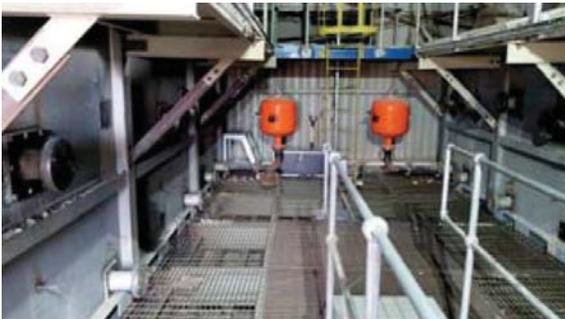
*The plant reported an immediate increase in production with less downtime on the material feed areas.*

By mid 2014 the first Martin® Hurricane Air Cannons had been installed and the plant reported an immediate increase in production with less downtime on the material feed areas. Due to the success of this project the plant has since applied for further capital to install more units on the lower kiln feed area to give totally reliable production capacity with the use of Martin® Hurricane Air Cannons.
