# PROBLEM SOLVED™ PAPER

**SOLUTION:** Martin® QC1™ Cleaner HD and Martin® DT2 Inline Cleaner.

**INDUSTRY:** Mining

**LOCATION:** PT Antan Nickel Mining, Pomalaa, Indonesia

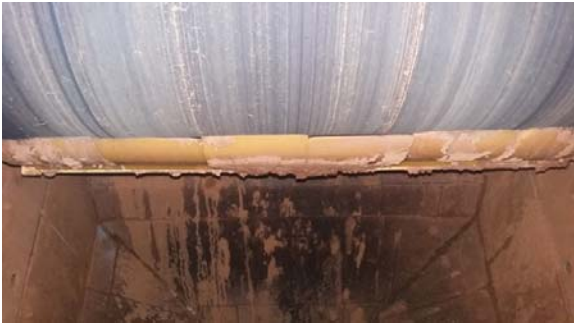
PT Antam Mining of Indonesia had inadequate belt cleaners causing belt damage, spillage and carryback on a reversing belt within the mine. Conveying 360,000 tonnes (397,000 tons) per month, the previous equipment did not keep a seal across the belt profile. Incomplete cleaning caused excessive carryback and spillage along the return belt path, increasing the need for cleanup. Rocks would wedge in the primary belt cleaner, breaking the splice and shredding the belt. Operators also realized that the secondary belt cleaner was not made to handle reversing belts, causing the belt to tear when the belt was reversed.

*Rocks would wedge in the primary belt cleaner, breaking the splice and shredding the belt.*

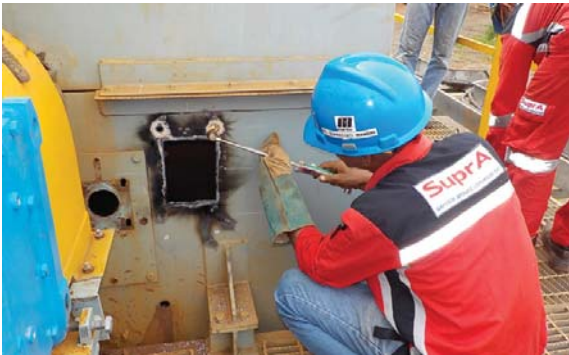
*Technicians examined the issue and installed a Martin® QC1™ Cleaner HD and Martin® DT2 Inline Cleaner.*

Technicians from P.T. Martin Supra Engineering, distributor of Martin Engineering equipment in Indonesia, examined the issue and installed a Martin® QC1™ Cleaner HD and Martin® DT2 Inline Cleaner Reversing. The Martin® QC1™ Cleaner HD has a single curved urethane blade with a Constant Angle Radial Pressure (CARP) design to keep a consistent seal on the belt. It combines sturdy performance with easy one-pin blade replacement. Using a tungsten carbide-tipped reversing blade to offer improved cleaning of dust and fines, the Martin® DT2 Inline Cleaner reduces laborious cleanup and prolongs the life of conveying equipment.

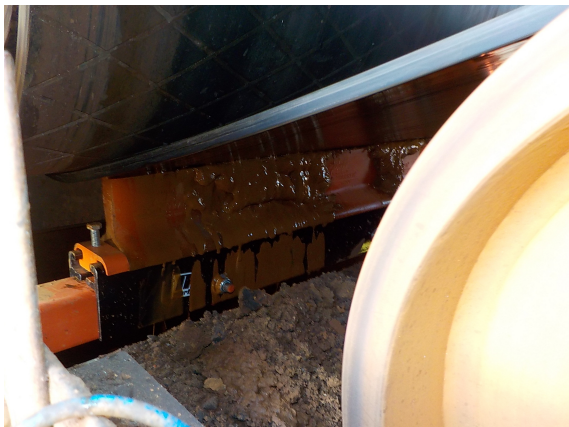
*Operators report that blades run easily over the belt and splice and that the system is running efficiently.*

Once the new equipment was installed, the customer noticed immediate results. Material no longer gets caught in between the blades, damaging the belt and splice. "Quite nice," said a P.T. Antam spokesperson. "The belt is clean of carryback and spillage is reduced. There has been no downtime for breakdowns due to belt damage so production is much smoother." The amount of labor time for maintenance and cleanup has been also cut. Operators report that blades run easily over the belt and splice and that the system is running efficiently.
