# PROBLEM SOLVED™ PAPER

**SOLUTION:** CleanScrape® Cleaner & SQC2™ Secondary Cleaner

**LOCATION:** Modane, France

**TITLE:** Delivering cleaner belts, lower maintenance, and safer operations.

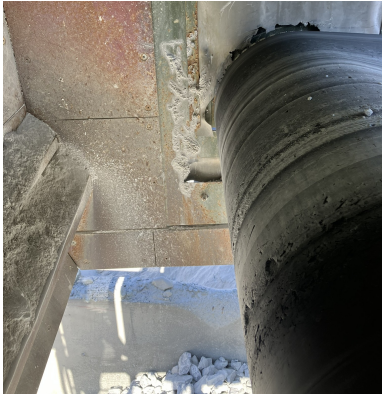
Persistent carryback accumulated along the return belt

One of Europe's largest infrastructure construction sites experienced significant belt conveyor carryback issues on a critical material handling system. The 1200 mm wide conveyor, carrying gravel at a speed of 3.2 m/s, was fitted with competitor belt cleaners that consistently failed to deliver effective cleaning performance. As a result, persistent carryback accumulated along the return belt. The root cause was identified as inefficient cleaning from the previously installed system, which was unable to maintain consistent belt contact and cleaning effectiveness. Despite repeated attempts to resolve the issue using the existing supplier's equipment, the problem remained unresolved, requiring a more reliable and proven solution.

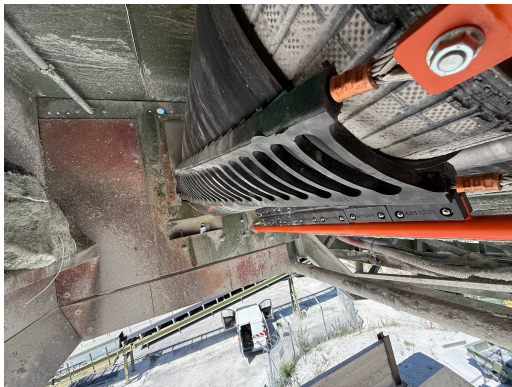
CleanScrape® Primary Belt Cleaner delivers efficient and uniform cleaning across the full width of the belt

In collaboration with our partner, Iméco, we conducted a thorough evaluation of the conveyor system and recommended a proven belt cleaning configuration based on successful results achieved in similar installations. The proposed solution comprised a CleanScrape® primary belt cleaner together with a SQC2™ Reduced Mini Cleaner. This configuration was selected for its key advantages: CleanScrape® technology delivers consistent and uniform cleaning across the full width of the belt, including the edges, while its low-maintenance design minimizes the need for frequent adjustments. In addition, the SQC2™ Reduced Mini Secondary Cleaner effectively removes any remaining fines, ensuring optimal belt cleanliness.

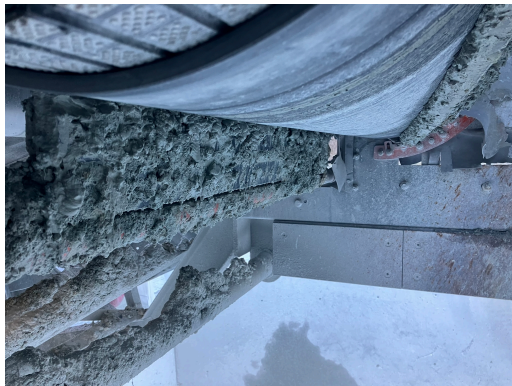
SQC2™ Reduced Mini Cleaner effectively removes any remaining fines
