# PROBLEM SOLVED™ PAPER

**SOLUTION:** Martin® Tracker™

**TITLE:** Martin® Tracker™ Resolves Belt Sway and Spillage in Iron Ore Mining

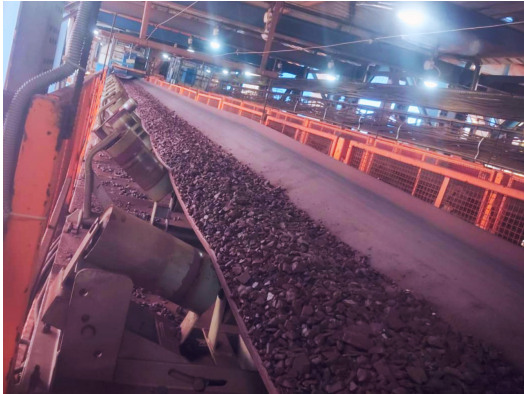
Tata Steel's Joda East Iron Mines in Odisha, was facing severe material spillage on a conveyor belt

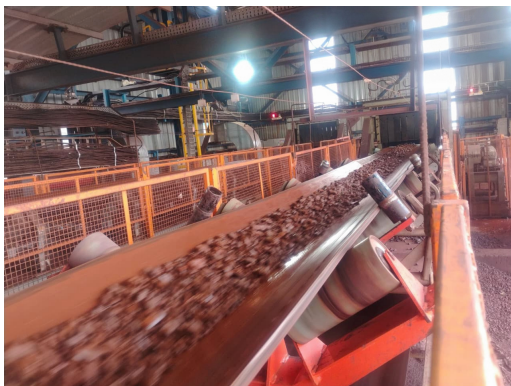
Belt sway was effectively eliminated, leading to a significant reduction in material spillage.
