PROBLEM SOLVED™ PAPER

SOLUTION: Typhoon Air Cannon, SMART™ Series Nozzle, Martin® Core Gate

INDUSTRY: Cement

LOCATION: JK Cement Works, Nimbahera, Rajasthan, India

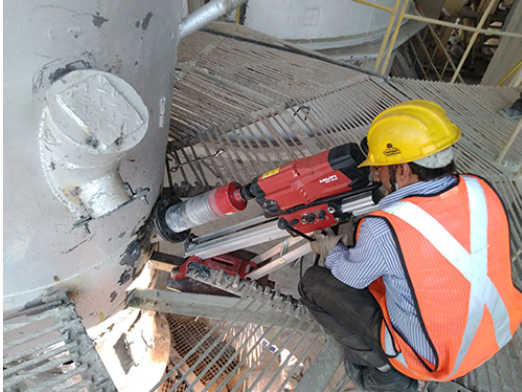
Holes are drilled at approximately a 30° angle to support the flow of material.

Technicians from Martin Engineering India were invited to examine the issue, and they decided to install two air cannons at the clogging point. Buildup is common in preheater towers and can take up to 10 days of downtime for cooling, cleaning and reheating. By using a Martin® Core Gate, holes were carefully drilled through the refractory during operation, then the air cannon assemblies were installed. Using a 70L Martin Typhoon Air Cannon connected to the plant's compressed air system and a SMART™ Series Jet Nozzle designed for high-temperature environments, each unit delivers a powerful shot of air that dislodges adhered material. The cannons were set to fire automatically at predefined intervals.

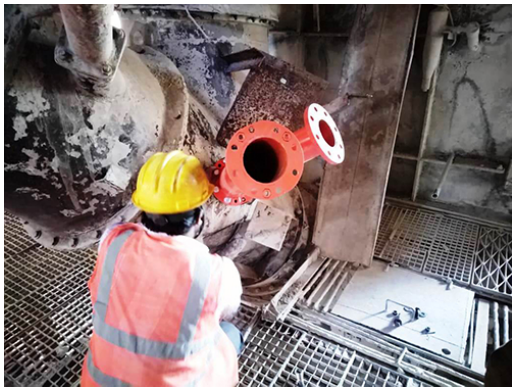
The Y-Shaped assembly allows the nozzle and cannon to be installed and replaced easily.

The drilling and installation only took two hours. With the ability to service and maintain the valve and nozzle without removing the tank or assembly, a permanent solution was provided that significantly reduced maintenance labor, while improving safety. Moreover, dislodging adhered material before it accumulates means the problem area no longer requires manual cleaning. "We have never seen this done in a running cement plant, said an operator close to the project. "We are very happy with the performance." Managers are now working with Martin Engineering India to install a similar air cannon solution in other parts of the tower and throughout the plant.

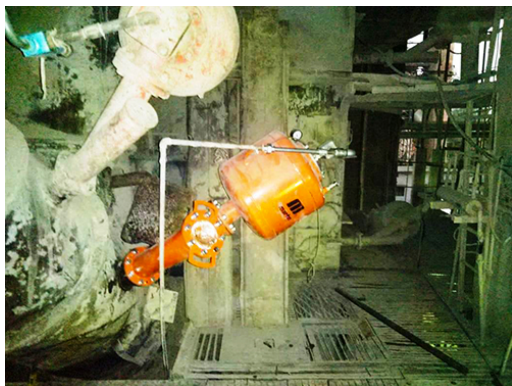
The 70L Martin® Typhoon Air Cannon dislodges accumulation over a large area.
