# PROBLEM SOLVED™ PAPER

**SOLUTION:** Martin® Multi Port Air Cannon

**LOCATION:** Cement Plant in Turkey

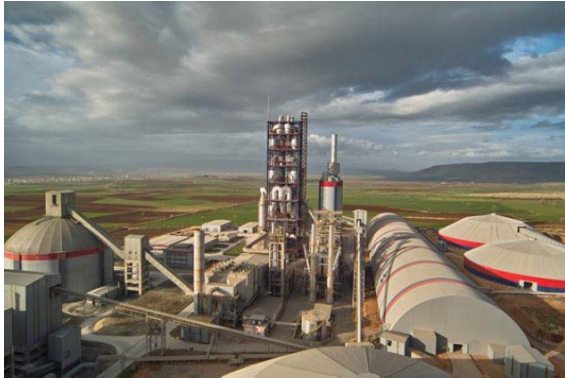
*A cement plant in Turkey with the highest clinker production capacity was having problems with material flow.*

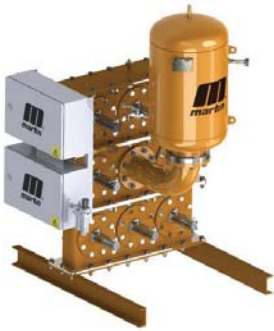
*Martin installed a Martin® Multi Port Air Cannon to correct the material flow problems.*

Martin installed the Martin® Multi Port Air Cannon to correct the material flow problems in the most effective and efficient way, and also to eliminate the risk to the workers who had to manually clean and maintain the area.

The Martin® Multi Port Air Cannon uses one air tank that discharges to eight ports through stainless steel hoses to improve process efficiency. The Martin® Multi Port Air Cannon keeps moving components centralized, so they are easier to service. Service is safer too, because workers stay away from hazardous conditions.

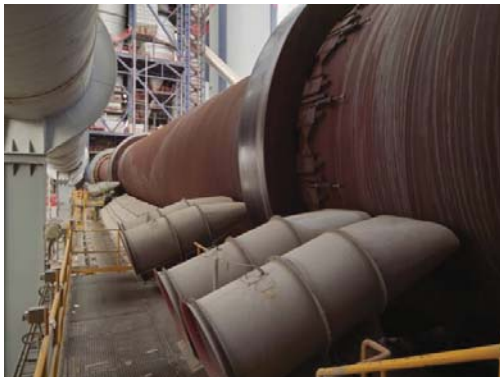
*The cement plant has reported that the material flow problem has been eliminated.*

The cement plant has reported that the material flow problem has been eliminated and want to continue working with Martin on additional efficiencies.
