PROBLEM SOLVED™ PAPER

SOLUTION: Martin® Belt Cleaners, Transfer Chutes, Settling Zones, ApronSeal, Vibration

INDUSTRY: Biomass

LOCATION: Hibbing Public Utilities in Hibbing, Minnesota

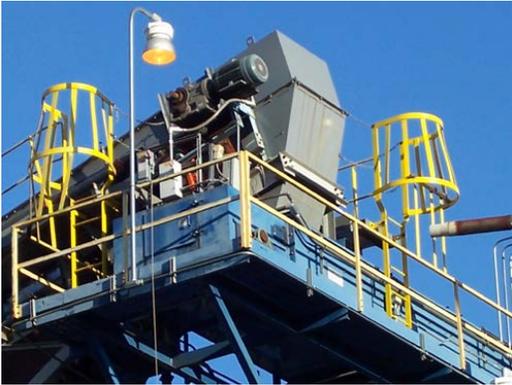
This section of existing air-supported conveyor was modified to relieve spillage.

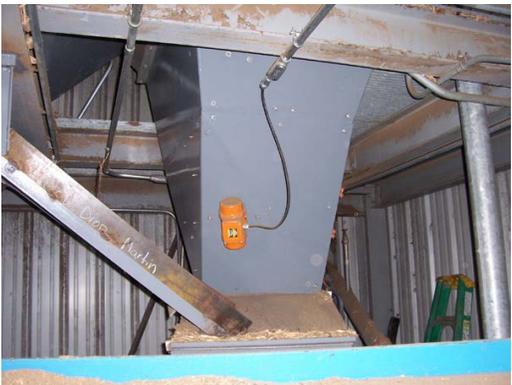
A field-fabricated drop chute was fitted with a Martin Vibrator to eliminate plugging and improve material flow to the new transfer point.

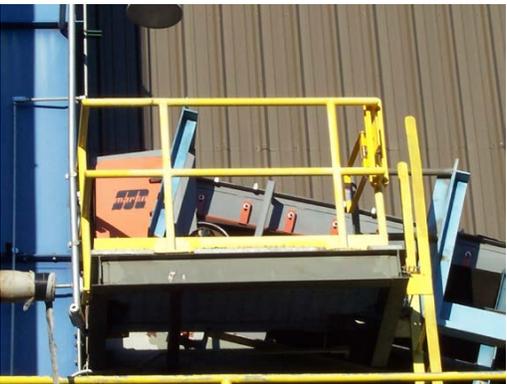
A new head chute and brush cleaner were installed at the bucket elevator, eliminating plugging and reducing dust by an estimated 95% in this area.
