ASIA Miner

VOLUME 17 • ISSUE 1 • INDUSTRY TECHNICAL INFORMATION • 矿业技术信息

Reducing conveyor maintenance time through better access

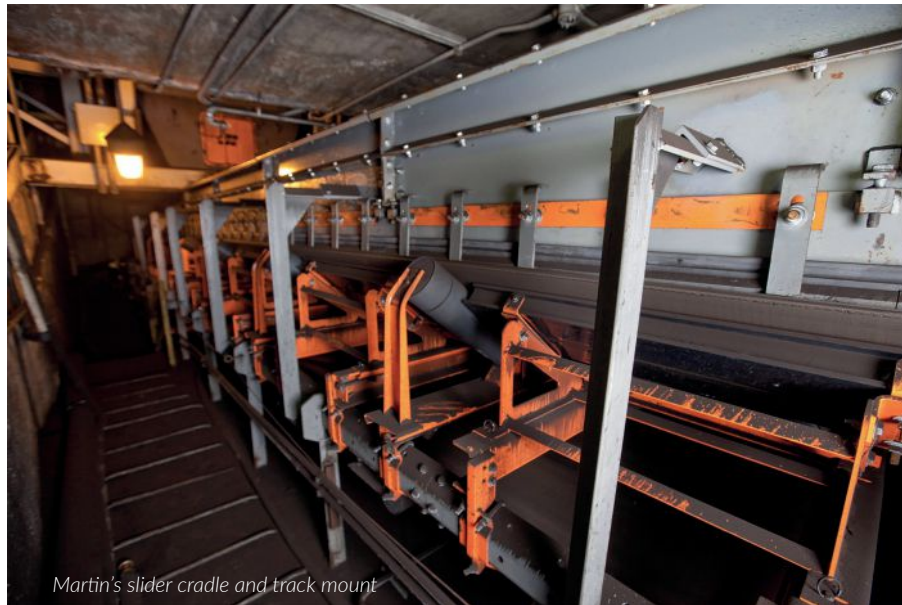
Martin's slider cradle and track mount

To reduce maintenance time and labour, improve safety and extend equipment life, operators should consider track-mounted impact cradles and belt support cradles. Located under the skirtboard and mounted with rugged steel assemblies, the cradles feature large impact absorbing UHMW polymer ‘box bars’ engineered with smooth surfaces that the belt can slide across with little friction or belt wear.

“These assemblies can be pulled out by a single worker and – working safely from outside the conveyor and using

only a single tool – the box bars can be simply removed and flipped in a matter of minutes to double the service life,” added Mr Marshall.
