# DRY CARGO

ISSUE NO. 271 AUGUST 2023

## Budge the sludge: ore mine uses air cannons to unclog chutes

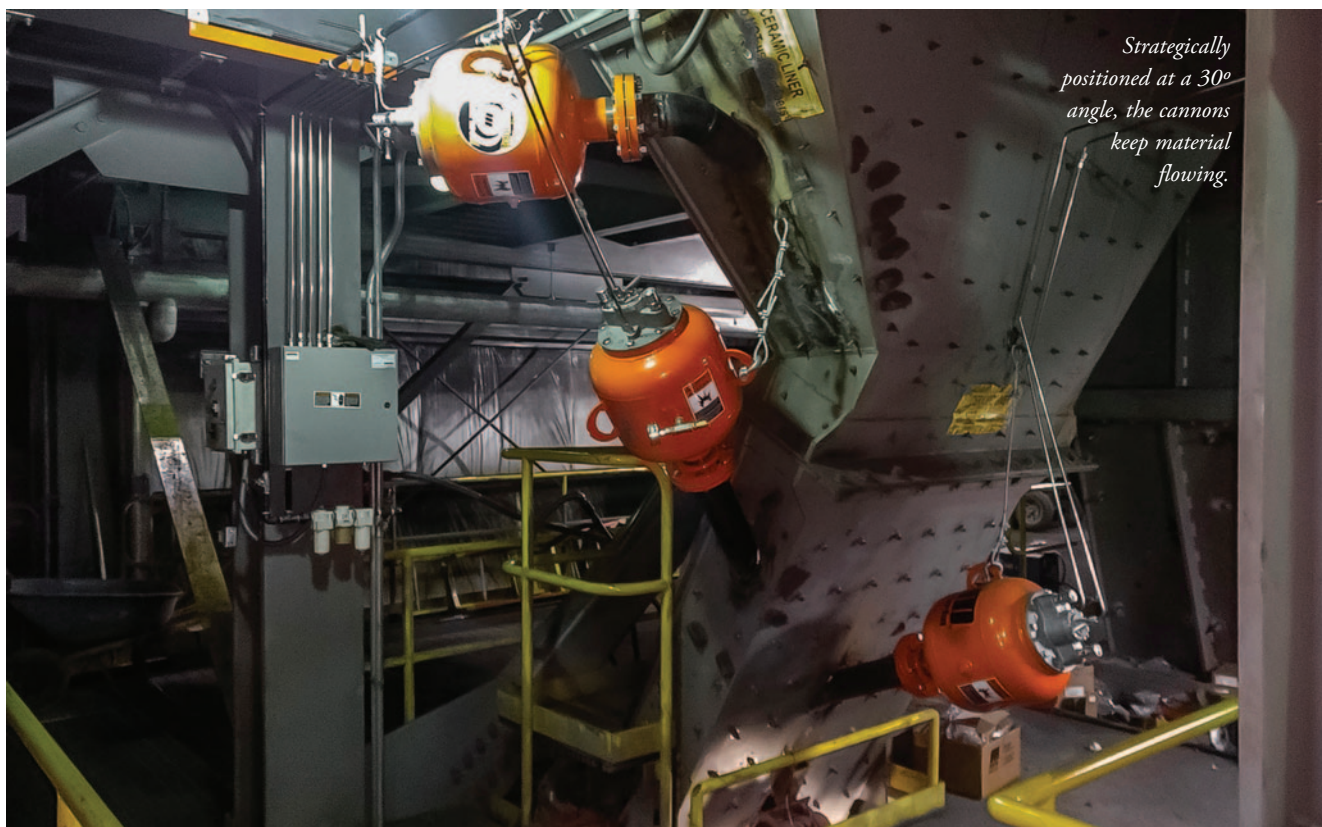
*Strategically positioned at a 30° angle, the cannons keep material flowing.*

removed the lining and cut holes to fit the air cannon pipe assemblies, which pointed at a 30° angle in the direction of the cargo stream. Beginning with five cannons, one unit was placed at the area where material discharged into the hopper, two others were positioned at the hopper slope where the most accumulation was observed and two more were placed along the drop chute. These used straight pipe nozzles to shoot air across the vessel to dislodge adhered material and promote flow.

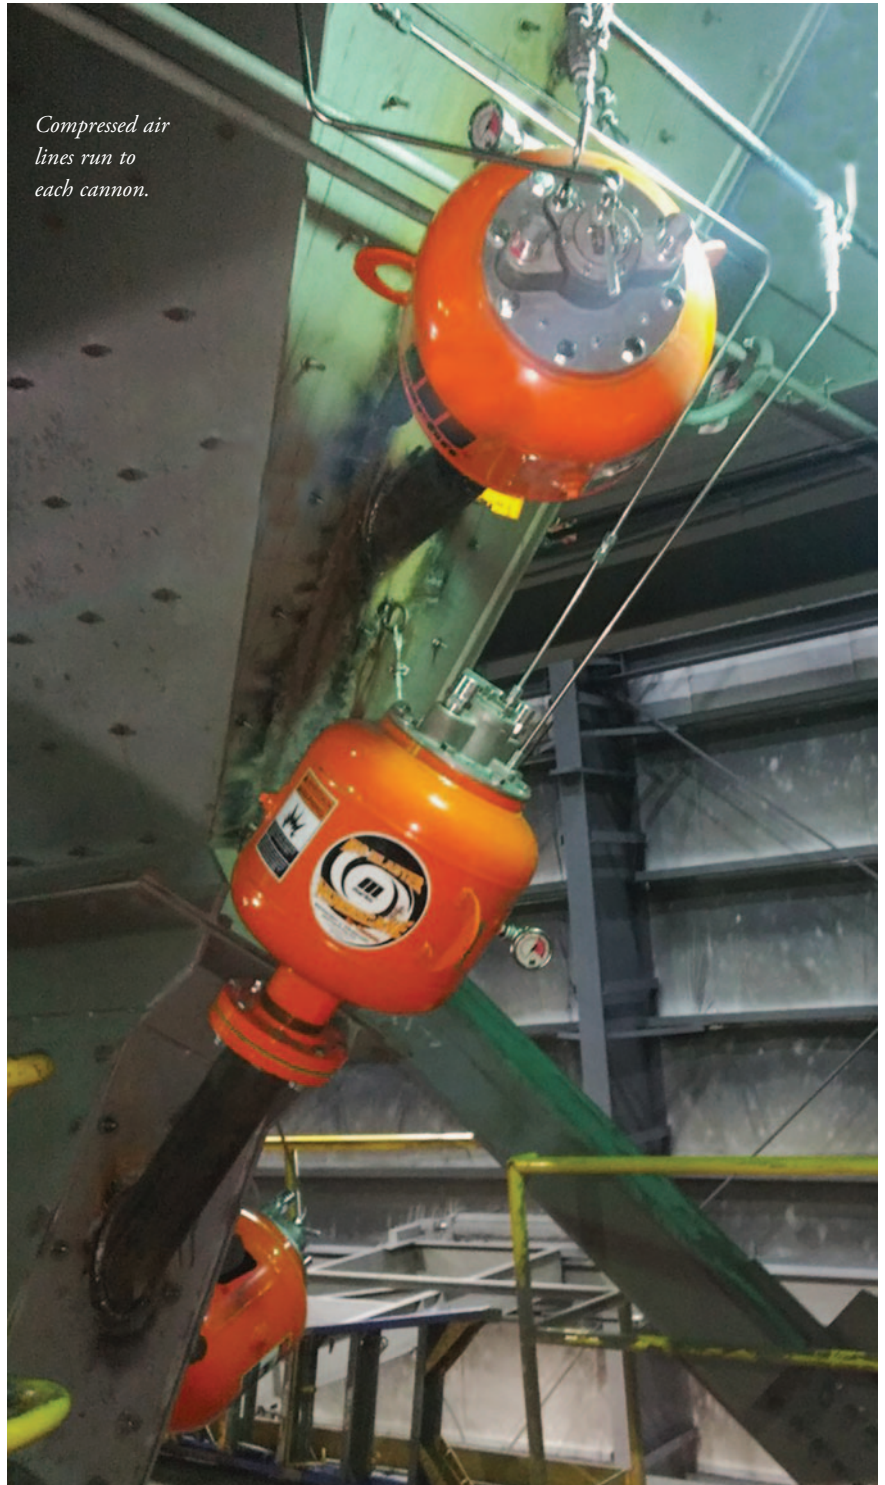
*Compressed air lines run to each cannon.*
