# PIT & QUARRY

# KEEPING BELTS CLEAN

Strategies to avoid spillage, carryback, chute clogging and dust in your conveying system

BY DANIEL MARSHALL

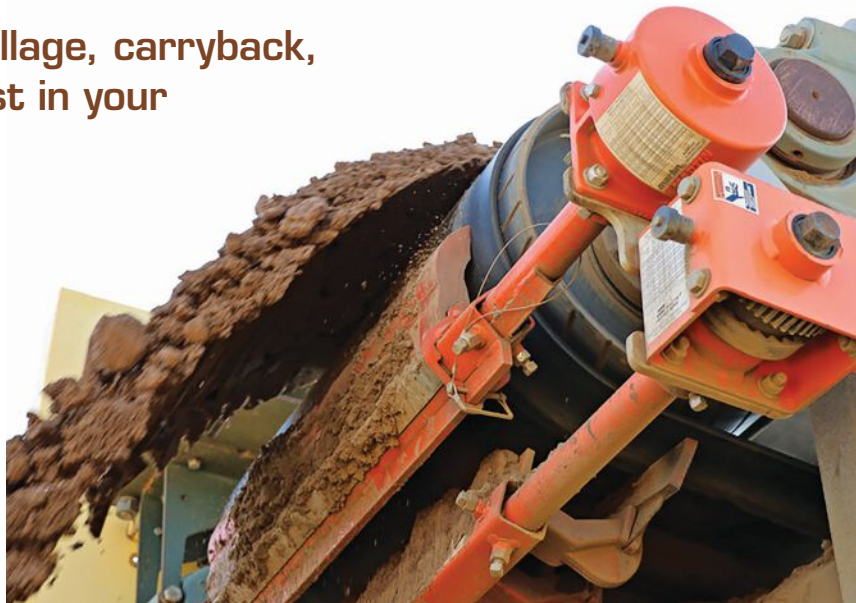
Discharge from a conveyor belt doesn't have to be dirty and dusty.

The discharge zone starts at the last troughed idler before the conveyor belt flattens and encounters the head pulley.

Cargo falls from the conveyor into a transfer “drop” chute that can lead to several places, including another conveyor, a storage silo or pile, or a transport vehicle. The primary cleaner is located after the discharge stream to clear any adhered material caused by the weight or characteristics of the cargo.

A secondary cleaner, meanwhile, clears dust and fines from divots and cracks in the belt. Material cleared from the secondary cleaner is generally directed to a sloped surface connected to the transfer chute.

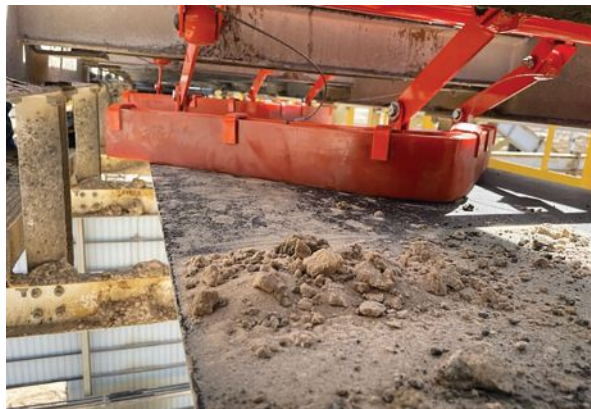
A plow diverts fugitive carryback to either side of the system, ensuring tail pulley health.

Also, consider a diagonal or v-shaped plow underneath the loading zone – right before the tail pulley – that rides on the

underside of the belt to remove loose traveling material.

For more effective cleaning and to reduce friction damage, consider a plow with torsion arms rather than one held in place by chains. Install belt trackers or crown rollers along the upper and low belt path to ensure alignment.

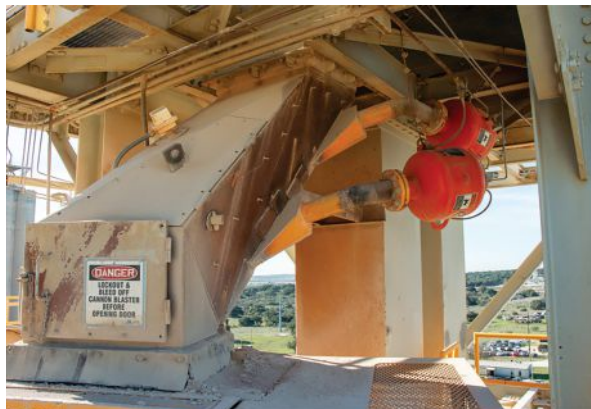
Air cannons can dislodge material and prevent buildup by distributing powerful shots of air inside a vessel.

To avoid these unsafe approaches, air cannons can strategically be installed around the chute and have nozzles pointed in the direction of the material flow. Powerful shots of air can be distributed across the surface inside the vessel, dislodging material and preventing buildup.

Air cannons are supported by vibration units that ensure gates and narrow spouts on hoppers and chutes retain proper flow before bridging starts. In many cases, vibration alone can

handle most dry material flow, but changes in humidity raising the stickiness of cargo and chute surfaces, along with fluctuations in production volumes, are much better handled by air cannons.
