# PROBLEM SOLVED™ PAPER

**SOLUTION:** Martin® QC1™ Cleaner HD and Martin® DT2 Inline Cleaner.

**INDUSTRY:** Mining

**LOCATION:** PT Antan Nickel Mining, Pomalaa, Indonesia

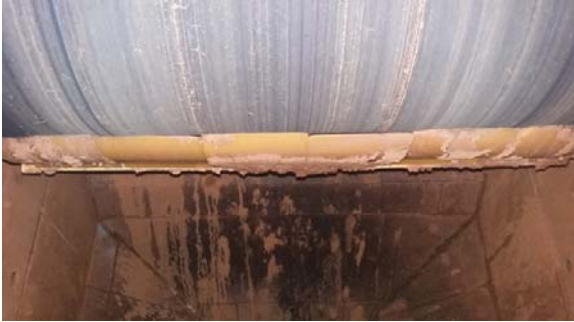
PT Antam Mining of Indonesia had inadequate belt cleaners causing belt damage, spillage and carryback on a reversing belt within the mine. Conveying 360,000 tonnes (397,000 tons) per month, the previous equipment did not keep a seal across the belt profile. Incomplete cleaning caused excessive carryback and spillage along the return belt path, increasing the need for cleanup. Rocks would wedge in the primary belt cleaner, breaking the splice and shredding the belt. Operators also realized that the secondary belt cleaner was not made to handle reversing belts, causing the belt to tear when the belt was reversed.

*Rocks would wedge in the primary belt cleaner, breaking the splice and shredding the belt.*

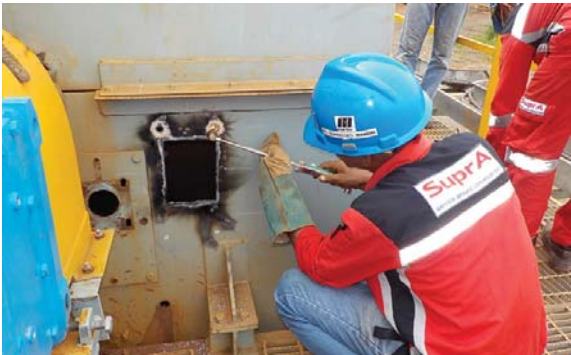
*Technicians examined the issue and installed a Martin® QC1™ Cleaner HD and Martin® DT2 Inline Cleaner.*

Technicians from P.T. Martin Supra Engineering, distributor of Martin Engineering equipment in Indonesia, examined the issue and installed a Martin® QC1™ Cleaner HD and Martin® DT2 Inline Cleaner Reversing. The Martin® QC1™ Cleaner HD has a single curved urethane blade with a Constant Angle Radial Pressure (CARP) design to keep a consistent seal on the belt. It combines sturdy performance with easy one-pin blade replacement. Using a tungsten carbide-tipped reversing blade to offer improved cleaning of dust and fines, the Martin® DT2 Inline Cleaner reduces laborious cleanup and prolongs the life of conveying equipment.

Once the new equipment was installed, the customer noticed immediate results. Material no longer gets caught in between the blades, damaging the belt and splice. "Quite nice," said a P.T. Antam spokesperson. "The belt is clean of carryback and spillage is reduced. There has been no downtime for breakdowns due to belt damage so production is much smoother." The amount of labor time for maintenance and cleanup has been also cut. Operators report that blades run easily over the belt and splice and that the system is running efficiently.
