# PROBLEM SOLVED™ PAPER

**SOLUTION:** CleanScape® Cleaner & SQC2™ Secondary Cleaner

**LOCATION:** Modane, France

**TITLE:** Delivering cleaner belts, lower maintenance, and safer operations.

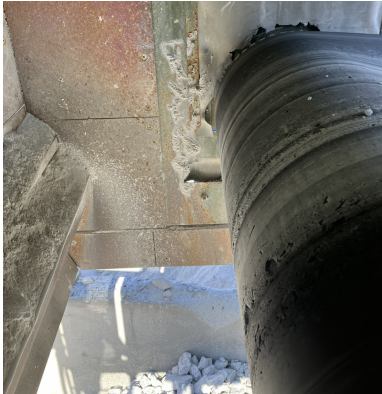
Persistent carryback accumulated along the return belt

One of Europe's largest infrastructure construction sites experienced significant belt conveyor carryback issues on a critical material handling system. The 1200 mm wide conveyor running at 3.2 m/s was fitted with competitor belt cleaners that consistently failed to deliver effective cleaning performance. As a result, persistent carryback accumulated along the return belt. The root cause was identified as inefficient cleaning from the previously installed system, which was unable to maintain consistent belt contact and cleaning effectiveness. Despite repeated attempts to resolve the issue using the existing supplier's equipment, the problem remained unresolved, requiring a more reliable and proven solution.

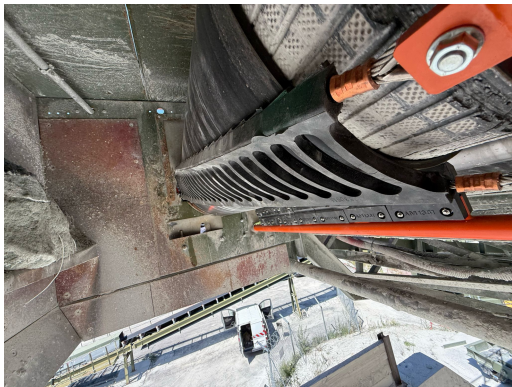
CleanScape® Primary Belt Cleaner delivers efficient and uniform cleaning across the full width of the belt

In collaboration with our partner, Iméco, we conducted a thorough evaluation of the conveyor system and recommended a proven belt cleaning configuration based on successful results achieved in similar installations. The proposed solution comprised a CleanScape® primary belt cleaner together with a SQC2™ Reduced Mini Cleaner. This configuration was selected for its key advantages: CleanScape® technology delivers consistent and uniform cleaning across the full width of the belt, including the edges, while its low-maintenance design minimizes the need for frequent adjustments. In addition, the SQC2™ Reduced Mini Cleaner secondary cleaner effectively removes any remaining fines, ensuring optimal belt cleanliness.
