# PROBLEM SOLVED™ PAPER

**SOLUTION:** Martin® QB1™ Cleaner HD, Pin Latch Secondary Cleaner

**INDUSTRY:** Sugar , Food Processing

**LOCATION:** Athani Sugars Ltd, Karnataka, India

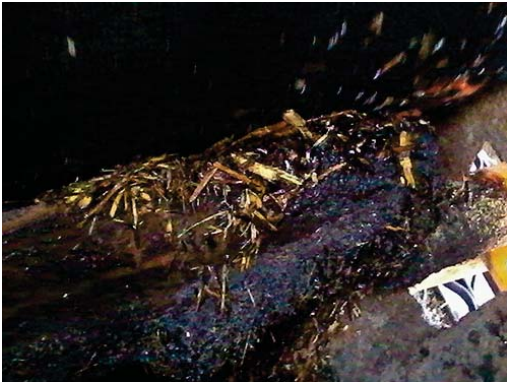
Bagasse generally consists of sugar cane husks and is often used as a biofuel.

Athani Sugars Ltd in Karnataka, Southwest India was experiencing severe amounts of carryback from sticky material on 4 conveyors transporting bagasse, clay and other viscous material. Conveyor widths range from 500 to 2000 mm (19.6 to 78.7 in.), and the systems transport 2500 tonnes (2755 tons) per day of material. Operators believed spillage along the entire belt path from material clinging to the return side of the belt was due to inadequate cleaning at the discharge zone. Workers would be pulled from other tasks and assigned to clean up around the area, as well as hose down the belt with water. This increased labor costs and created a burden on plant efficiency.

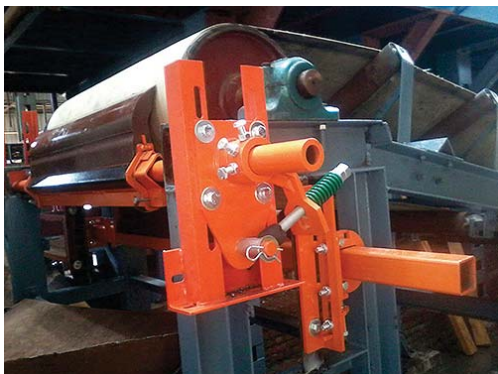
Spring tensioners ensure that the blade remains in firm contact with the belt, without damaging the splice.

Technicians from Martin Engineering India, located just outside of the nearby city of Pune, inspected the problem and recommended a Martin® QB1™ Cleaner HD for the primary cleaner, followed by a Martin® Pin Latch Secondary Cleaner. Manufactured with the strongest mainframe in the industry and a powerful spring tensioner, the QB1 HD uses Martin's patented Constant Angle Radial Pressure (CARP) technology to keep a tight seal on the belt throughout its life. These blades are customizable and can be cut to length in-house or delivered pre-cut. The Pin Latch sits behind the QB1 to clear dust and fines, and features individually cushioned tungsten carbide blades for effective cleaning without risk to the belt or splices.

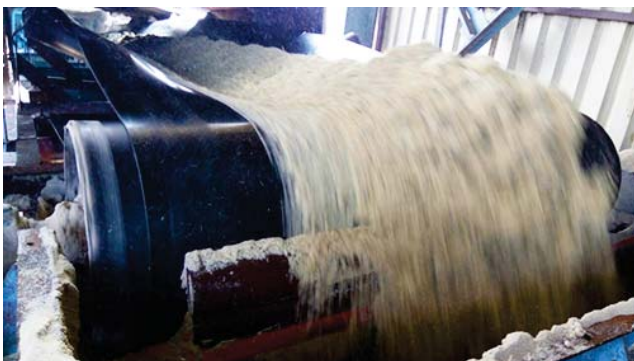
More material is discharged into the chute with less carryback, reducing the amount of spillage.

Operators report a significant reduction in spillage and carryback. Maintenance personnel no longer have to spend excessive time cleaning up, allowing them to focus their efforts on more productive activities. "Within just 30 minutes of installation, we could see a definite change, with better cleaning efficiency," said the plant's chief engineer. "We are very happy with the installation and outcome." Athani continues a strong relationship with Martin Engineering and intends to re-engage the company when the time comes for future projects and services.
