PROBLEM SOLVED™ PAPER

SOLUTION: Martin® Vibrating Dribble Chute

INDUSTRY: Mining

LOCATION: Hindustan Zinc Limited - Chittorgarh, Rajasthan (India)

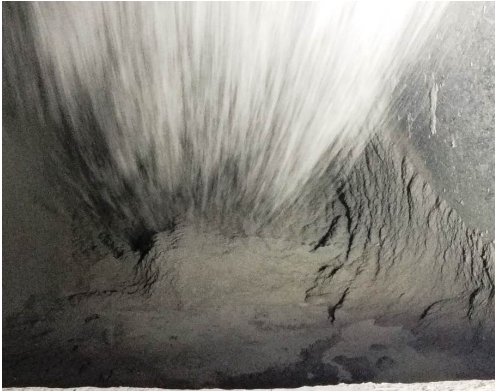
Substantial buildup was being observed on conveyor discharge chute wall, requiring periodic manual cleaning

A subsidiary of Vedanta limited, Hindustan Zinc - India's largest and world's second largest zinc-lead miner situated in Northwest India, was experiencing severe amounts of buildup on conveyor 09 discharge chute walls transferring 100TPH zinc concentrate. To overcome this, plant managers had modified it with increasing the front gap and also tried using UHMW as well as improved SS liner plates having 2B finish. Still due to material moisture content (8-12%), material buildup issue had not been resolved, so the final solution in use was, deputing manpower for doing manual cleaning for every 8 hours. But such frequent manual cleaning was costlier and also risky considering worker's safety.

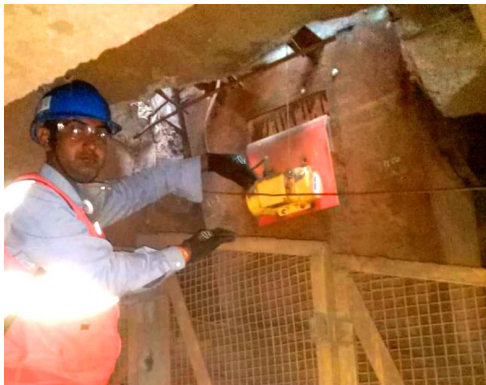
Vibrating Dribble Chute uses an electric vibrator and liner plate to avoid material clogging in discharge chute.

The Martin Engineering service engineer visited the site, audited the conveyor and recommended installing Martin® Vibrating Dribble Chute which uses an electric vibrator and a low-adhesion, low-friction UHMW chute liner to prevent buildup on discharge chute walls. Supplied Vibrating Dribble Chute used Cougar® Electric Vibrator Model B1-410-0A-2 with Adjustable Eccentric Weights. Includes ON/OFF switch with capacitors. It's mounting bracket incorporates rubber lining to isolate chute wall from bracket to reduce noise. UHMW Liner dribble sheet was field-modified to fit chute and provide necessary belt clearance.

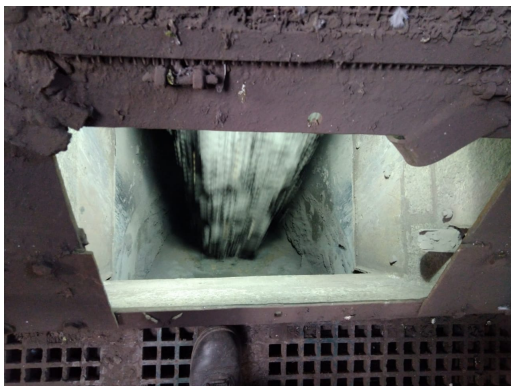
More material is discharged into the chute with no buildup and no manual cleaning

Operators reported a significant reduction in buildup and no material clogging. Maintenance personnel no longer have to spend excessive manpower and time cleaning up, allowing them to focus their efforts on more productive activities. "We are very happy with the installation, product's performance and now we don't require unsafe manual clean-ups" said the plant's Associate Manager (Mechanical). Hindustan zinc ltd. continues a strong relationship with Martin Engineering and intends to replicate the same solution to other conveyors facing the same issue.
